## Kingsclere

- a village with 95 listed buildings

Chris Watkins

2020

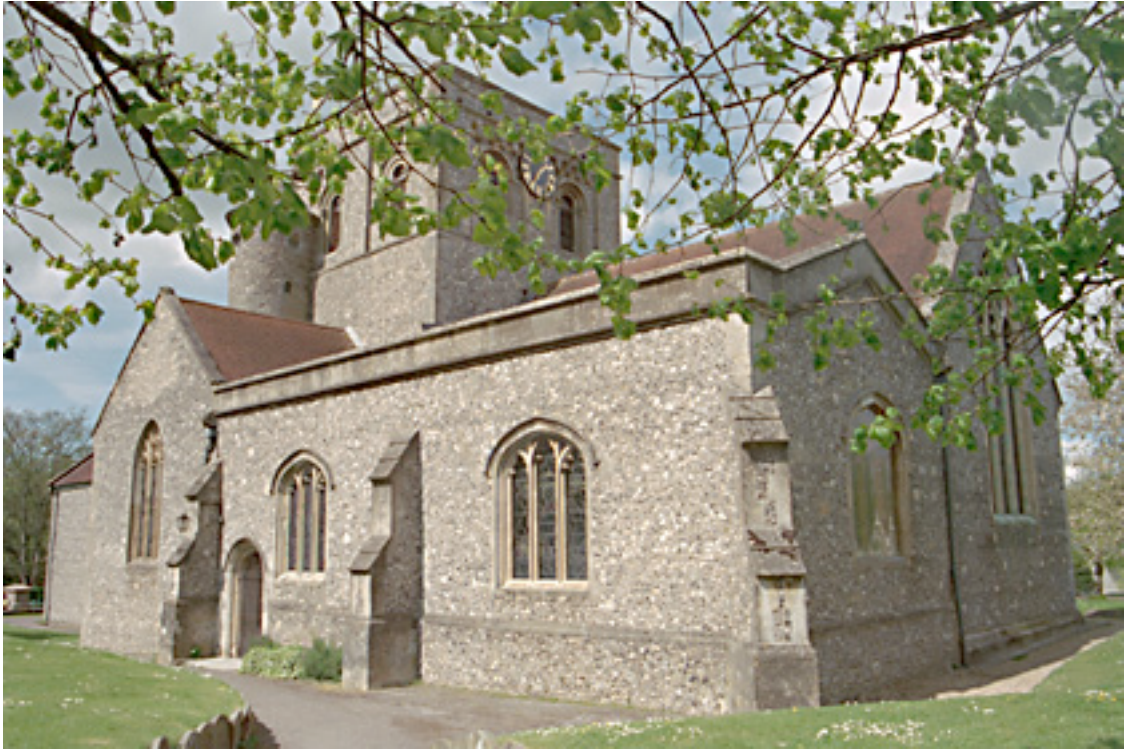
**Swan Street, Church of St Mary**

C12, C13, C15, with a substantial new construction and restoration by Hellyer and Ryde of 1843. On the site of a Saxon minister, a large cruciform Norman church, with a central tower, and a later south chapel. The restoration of 1848 accounts for the re-faced exterior, the raising of the tower, and walling of knapped flint with stone dressings; the details are 'Norman', with earlier fragments incorporated in the north door (now filled). The west door has recessed stages with moulded arches on columns, the south chapel has Perpendicular windows and stepped buttresses, the east window having 'Geometrical' tracery. The inside is severaly plain, with deeply-splayed 'Norman' lights to the nave, and an Early English arcade between the chancel and south chapel, having moulded caps. The chapel contains brasses of 1503, 1519 and 1580, as well as a number of C18 and early C19 wall monuments. The south transept has a donations board of 1830, and the tomb monument to Sir Henry Kingsmill (died 1620), and his wife Bridget (died 1672). Unique weather vane.

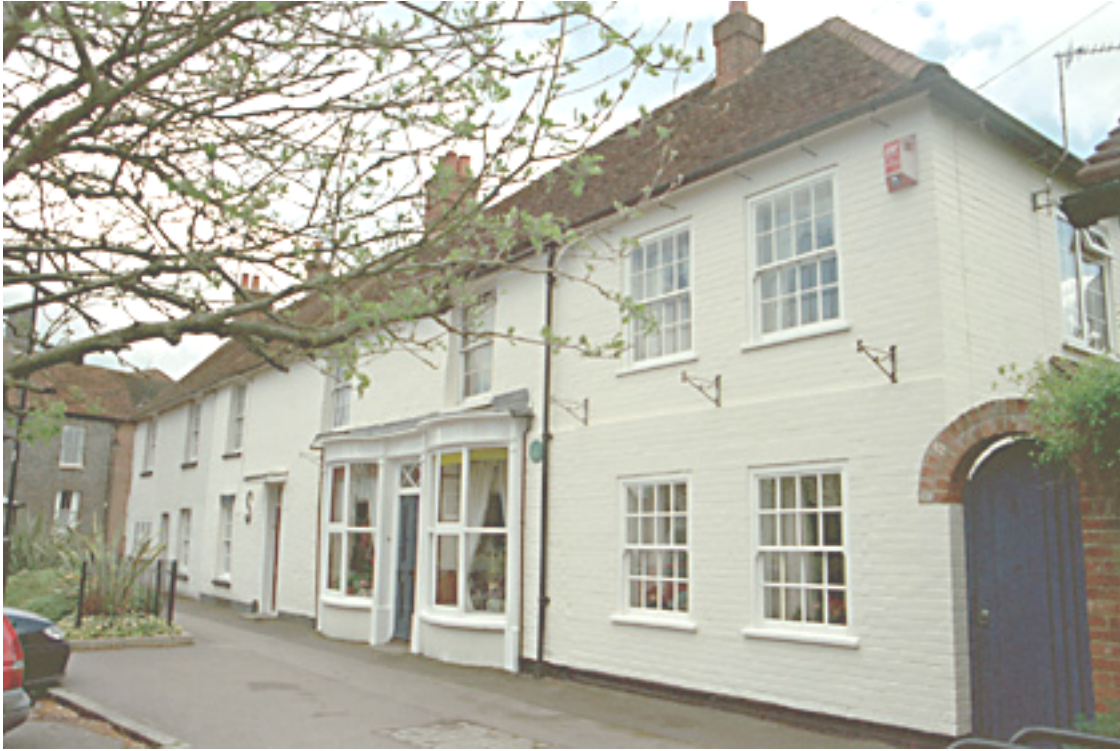
**1, 1a and 1b Swan Street**

C17, early C19. A short 2-storeyed terrace, being a refronting of a timber-frame; 5 regular upper windows to the front. Tile roof, hipped at the south end, the front hip being higher than the return south slope; wrought-iron eaves brackets. Painted brick walling in Flemish bond, 2 rubbed flat arches, stone cills. Sashes in reveals, one modern ground-floor casement: the south side has a double shop-front, with bow windows (with modern interior framing), a moulded cornice, thin fluted pilasters, a fanlight above the doorway with diagonal glazing bars. Modern doors, No 1a within a solid frame enclosing a fanlight and below a plain canopy. The north end gable has exposed framing, showing the front wall as an addition with a higher eaves level. The rear elevation has a lower eaves, 3 unequal gables, 2 being tile-hung.

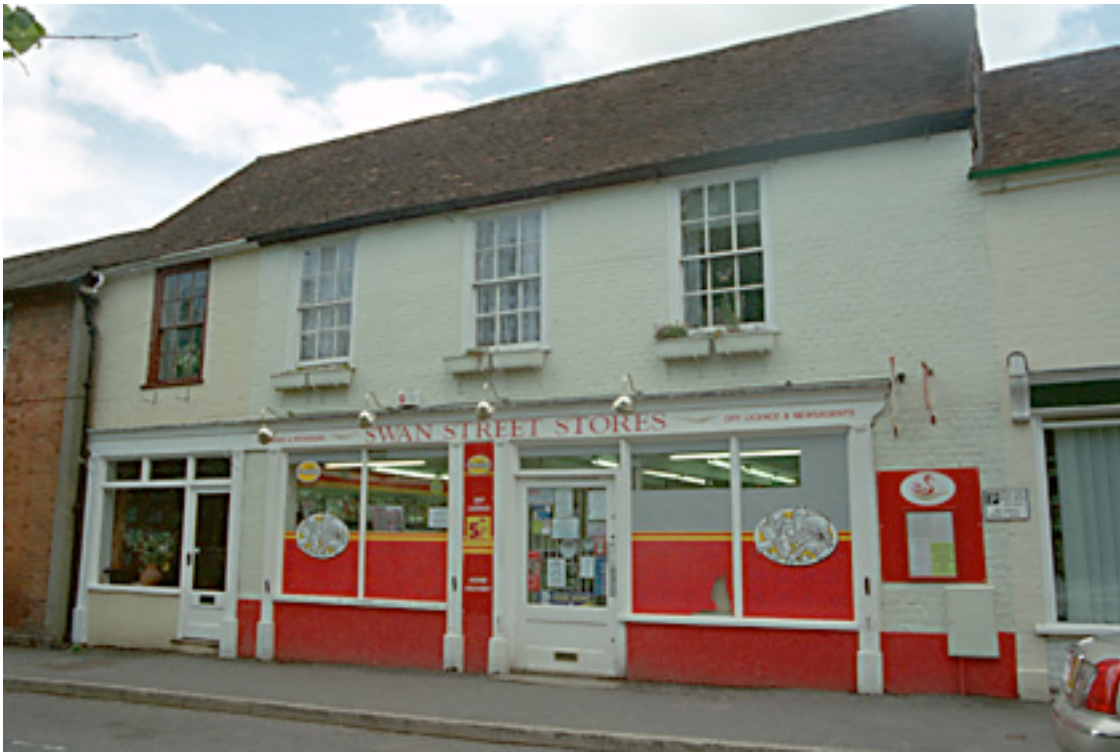
### 5 Swan Street

Late C18. Two storeys, 4 regular windows. Tile roof. Walling in blue header Brickwork. Sashes in exposed frames to the first floor. At the south side is a doorway with fanlight and panelled door; the remainder of the ground-floor is a shopfront, of 3 main bays separated by pilasters (coupled in the middle) supporting a continuous cornice and frieze.

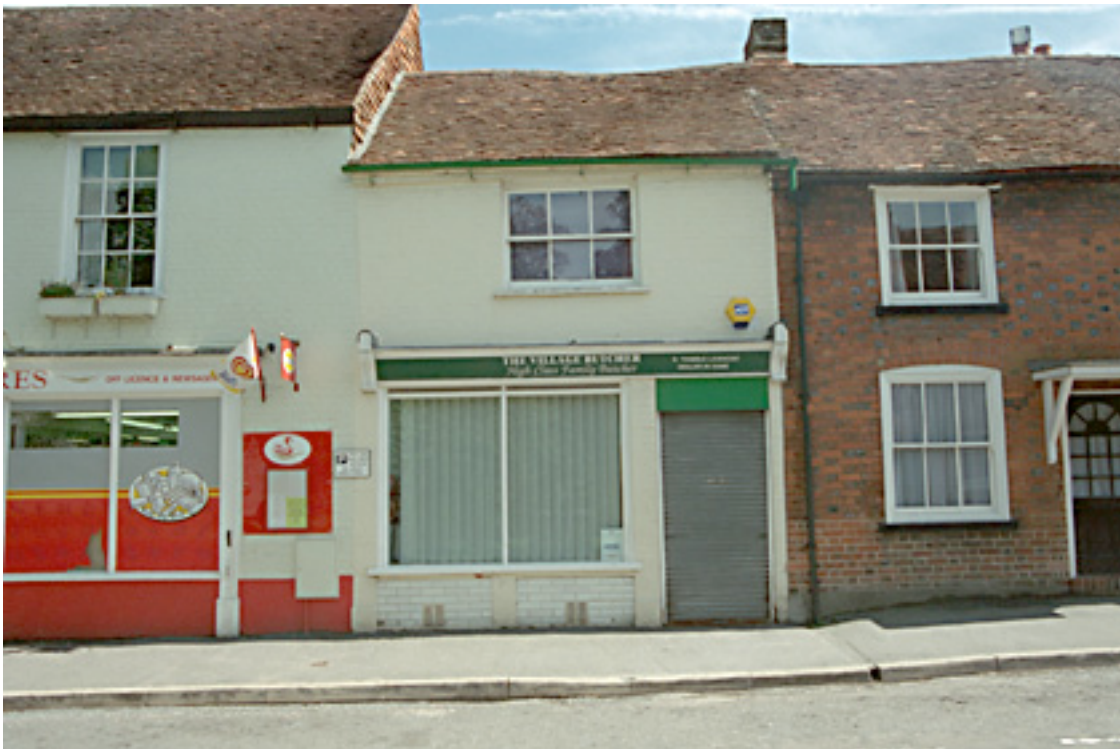
### 7 Swan Street

Early C19. Two storeys, one window. Tile roof. Painted brickwork in Flemish bond. Sash in exposed frame above modern shopfront. At the rear, a brick has been set in a wall, having the inscription 1615; this corresponds with some of the walling at the rear.

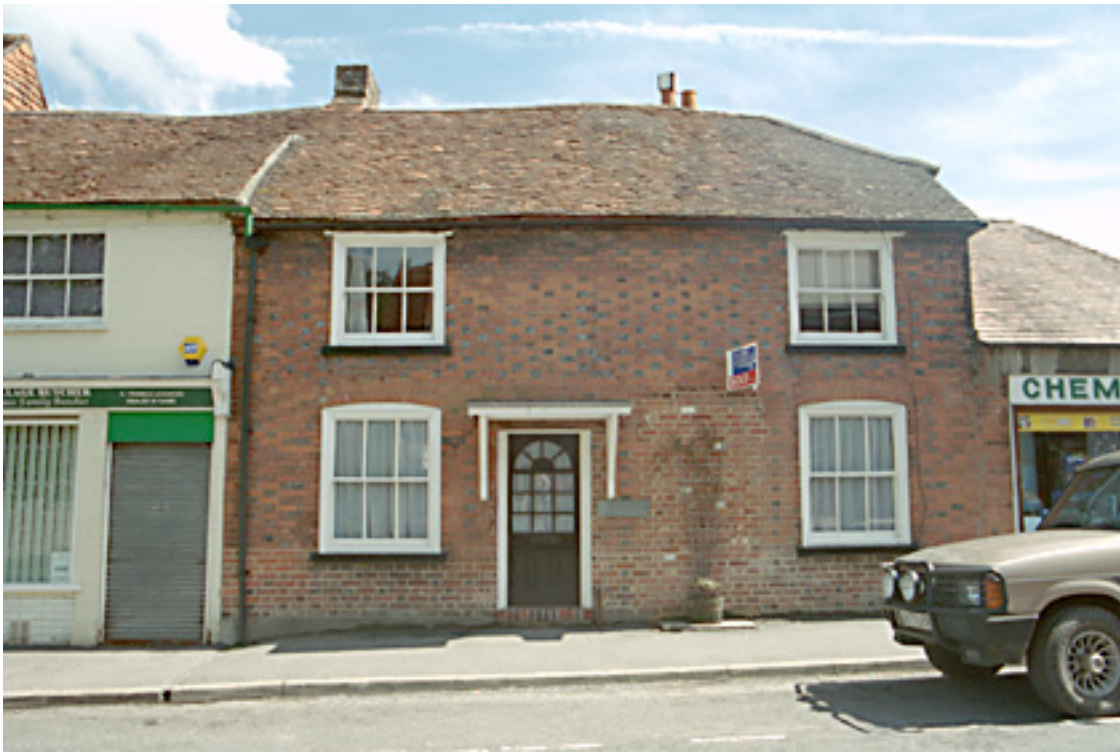
### **9 Swan Street, The Old Blacksmiths House**

Early C19. Two storeys, 2 windows. Tile roof, half-hipped at the south end, catslide to part of the rear. Red brick walling in Flemish bond with blue headers. Sashes in exposed frames. Thin doorcase-with a pediment-canopy, and half-glazed door.

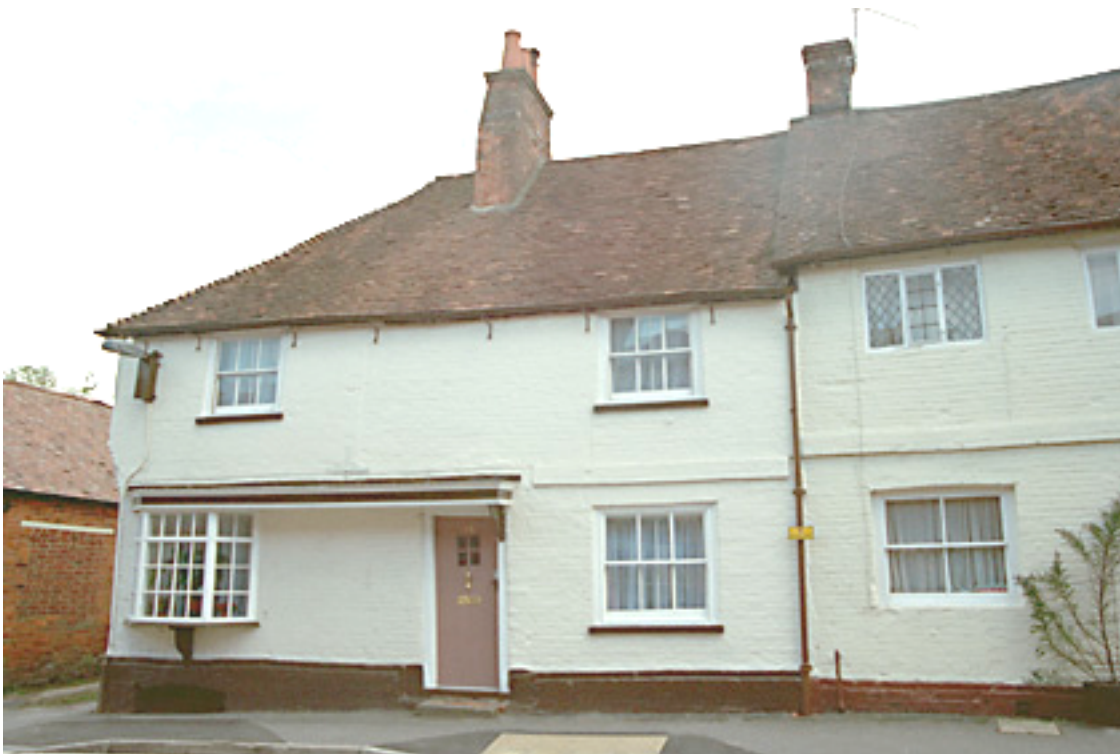
### **15 Swan Street**

C17, C18. Timber-framed house with a later front; 2 storeys, 2 windows. Tile roofing, hipped at the north side, wrought-iron eaves brackets. Painted brick walling, one rubbed flat arch, part-first-floor band, high plinth. Sashes in exposed frames; a long moulded cornice (former shopfront?) is carried above the (modern) door and a modern angled bay on a bracket, at the north side. The extensive rear of the building

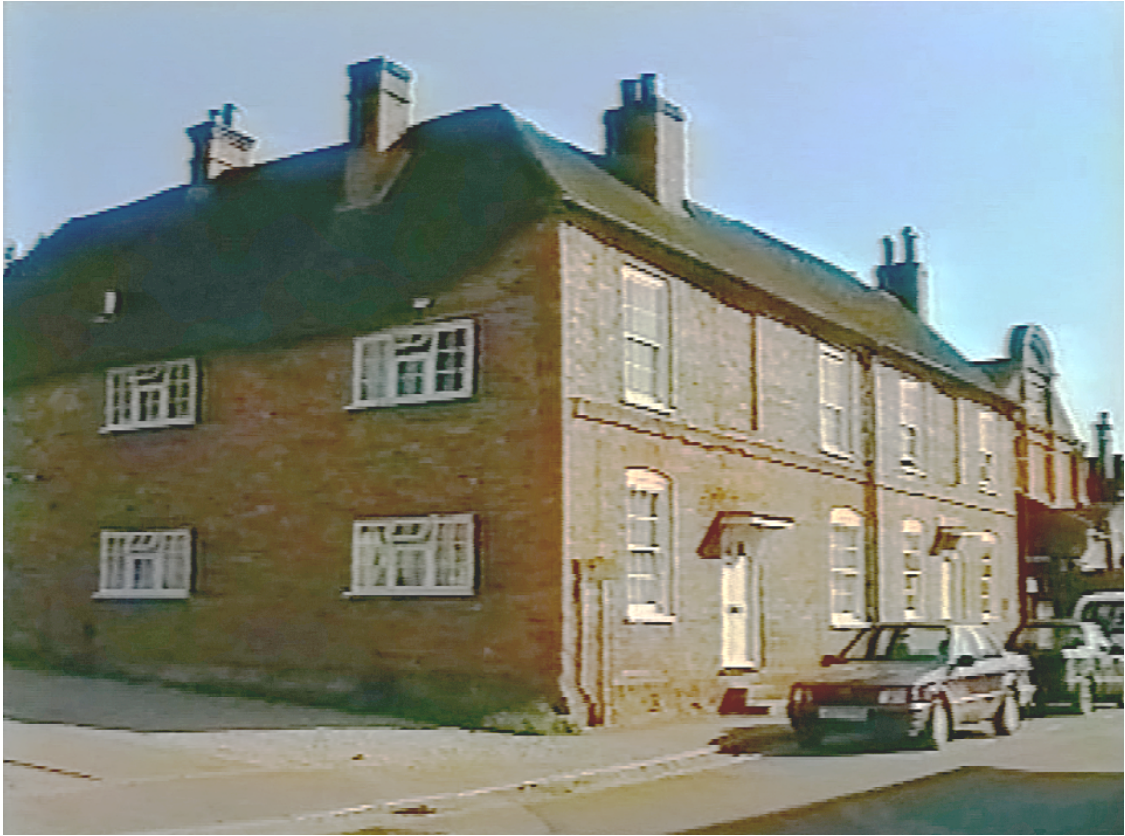
### **21 and 23 Swan Street, Warham House**

C15, C18, C19. A timber-framed building of late medieval origin, but refronted in the middle period; 2 storeys, 6 upper windows (2 blank above the doorways). Tiled roof, hipped at the north side, catslide at the rear, moulded brick eaves. Walling of the header brickwork with red flush dressings; quoins, panels containing the openings, first-floor band, cambered rubbed arches to the ground-floor, plinth. Sashes in exposed frames (one old). No 21 has a 6-panelled door in a solid-frame (without the former canopy); No 23 has a canopy and a panelled door in a solid frame. One plate glass shop window. The rear wing at the south side has a first-floor Gothic (sash) window. The north elevation shows that the front wall was raised above the earlier eaves height.

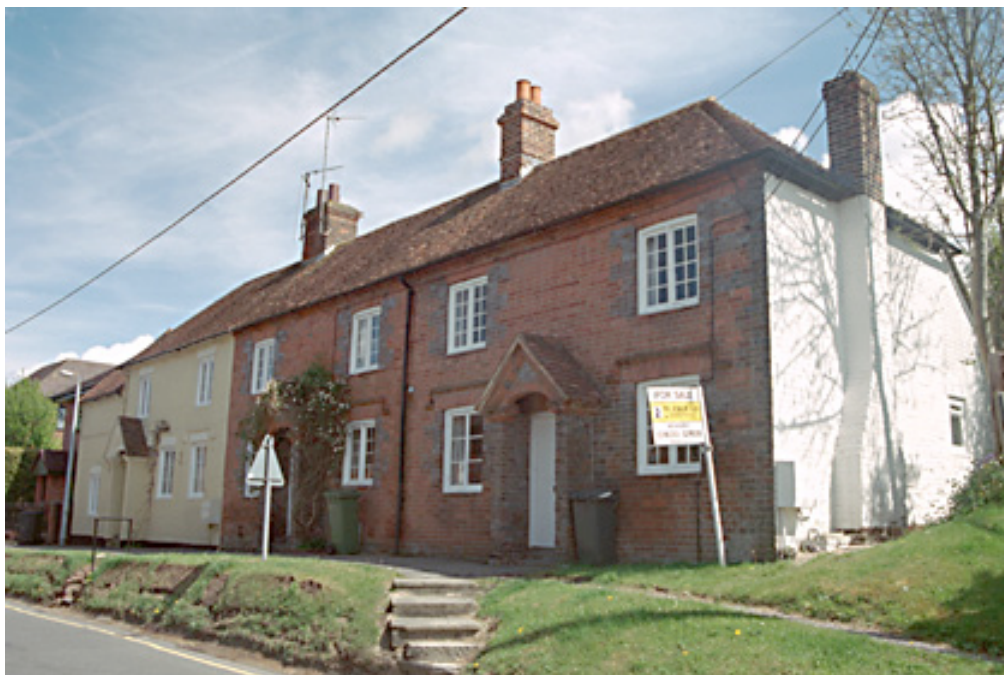
### **27 Swan Street, Brimley Hill Farmhouse**

C17, C19, C20. Two-storeyed timber-framed house, with later cladding at the front (north); 2 windows. Half-nipped tile roof, massive tapered brick stack at the west end. Cement walling; the east gable has exposed framing. Modern casements. 2 Victorian sashes to the ground floor. Plain doorway.

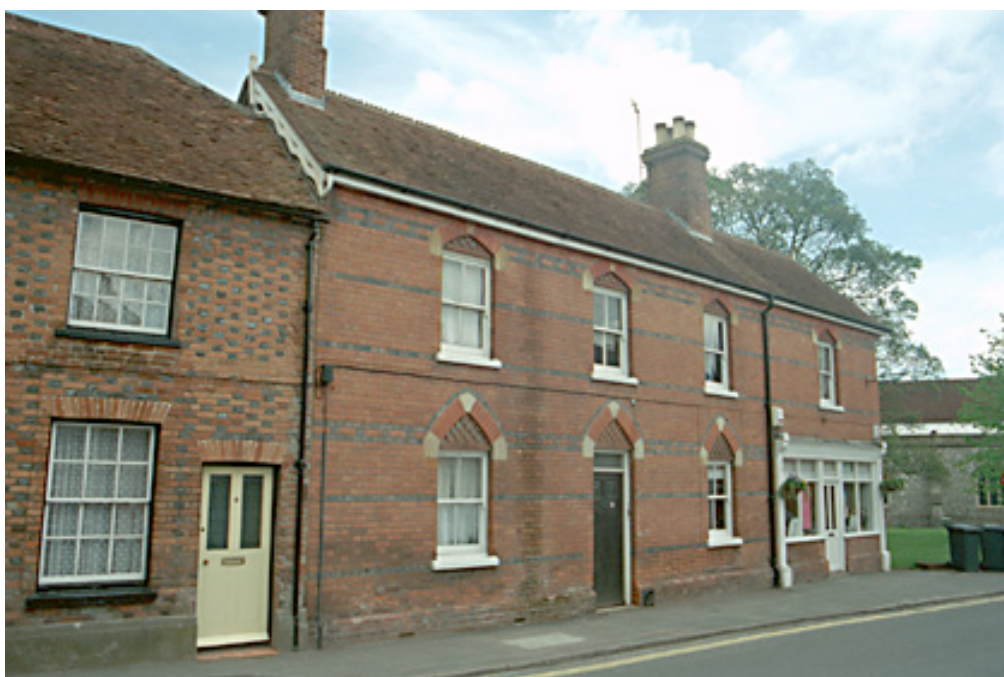
### **35, 37 and 39 Swan Street**

1852. A terrace arranged symmetrically, with a one-bay addition at the north end; 2 storeys, 1.2.2.2 windows. Hipped tile roof, with brick eaves moulding; the north unit is separate and slightly lower, with a hip to the front, and a brick dentil eaves. Red brick walling in Flemish bond with flush blue quoins to the openings, rubbed flat arches, and hood-moulds to the ground-floor. Casements. Shallow porches, with gable above an oval arch, brick moulded impost, deep pilasters. Above the centre is a diamond plaque incised 1852. No 35 (and the north unit) has painted brickwork, and the porch has been exchanged with the north side window (of the original design).

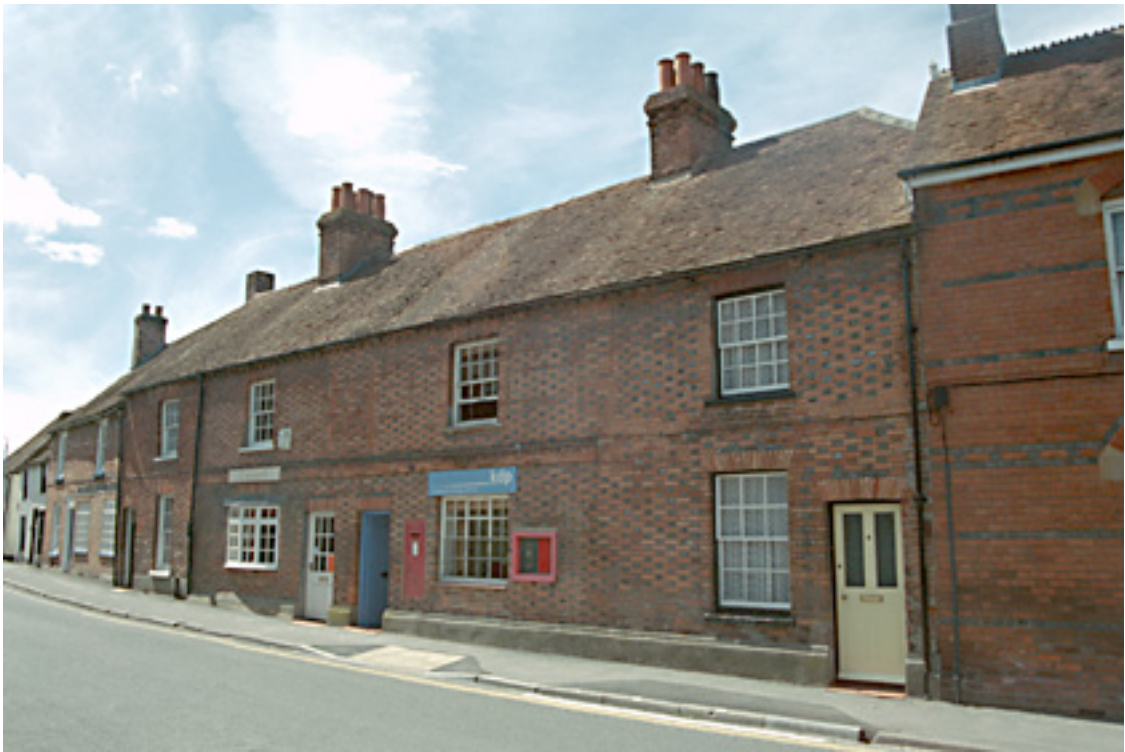
#### **6, 8, 10 and 12 Swan Street**

C18, C19. Terrace of 4 houses, with older central section. Tile roof, brick dentil eaves. Red brick walling in Flemish bond, with blue headers, first-floor band to 8 and 10, rubbed flat arches, stone cills, plinth. Early C19 sashes in reveals one modern window to No 8 (Post Office). Plain doors.

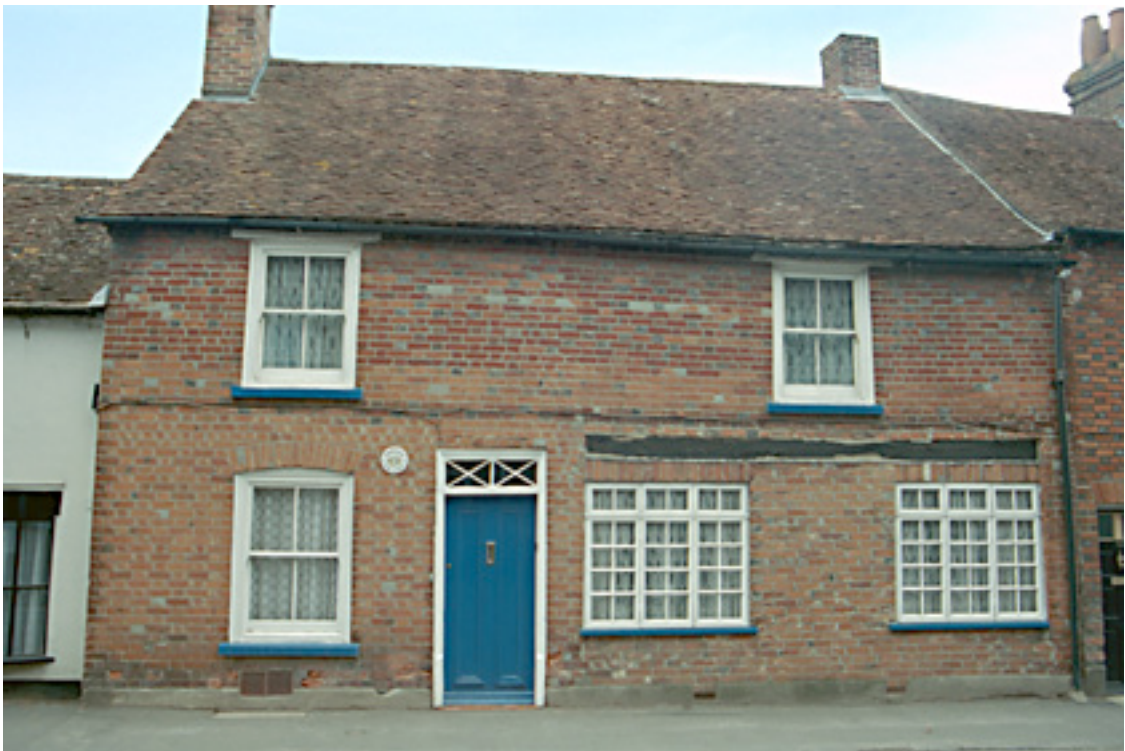
#### **14 Swan Street**

Early C19. Two storeys, 2 upper windows. Tile roof, stepped brick eaves. Red brick walling in Flemish bond, plinth. Victorian sashes in exposed frames. Two modern casements, to the ground-floor within new walling (replacing a shop front). Solid doorframe, enclosing a decorative fanlight, modern door.

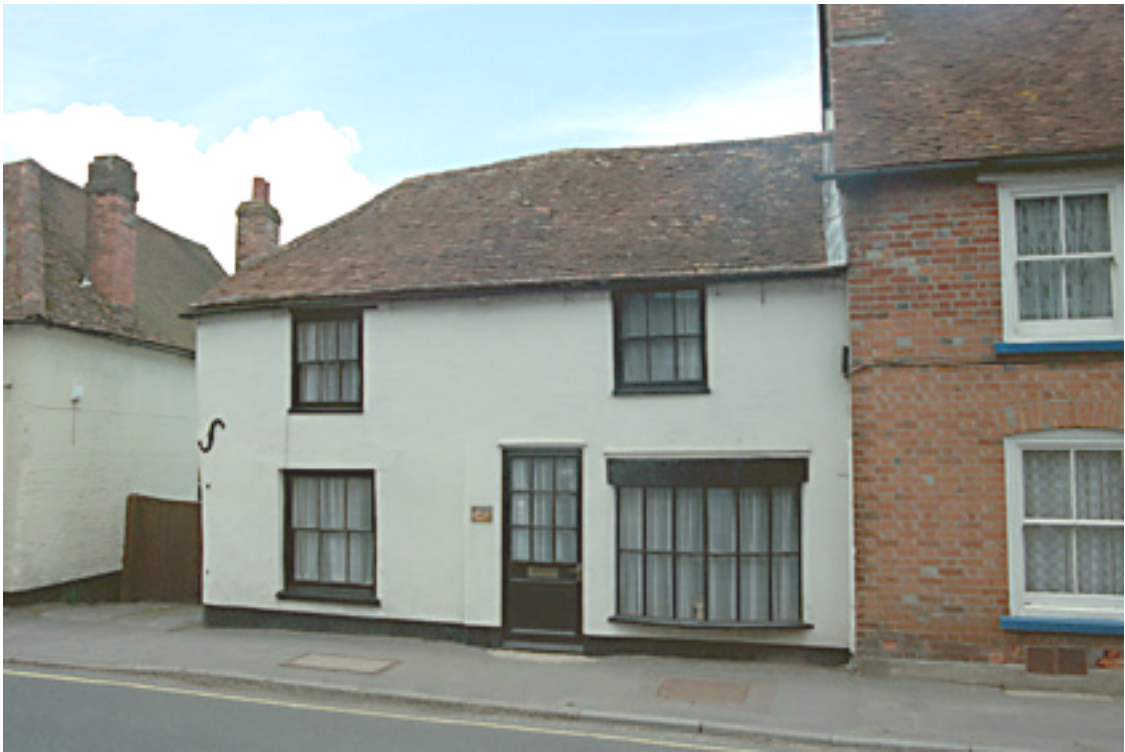
### **16 Swan Street**

Early C19. Small 2-storeyed cottage, of 2 windows. Tile roof, half-hipped at the south end. Rendered walling, plinth, rounded corner. Sashes in exposed frames, modern bow. Plain opening.

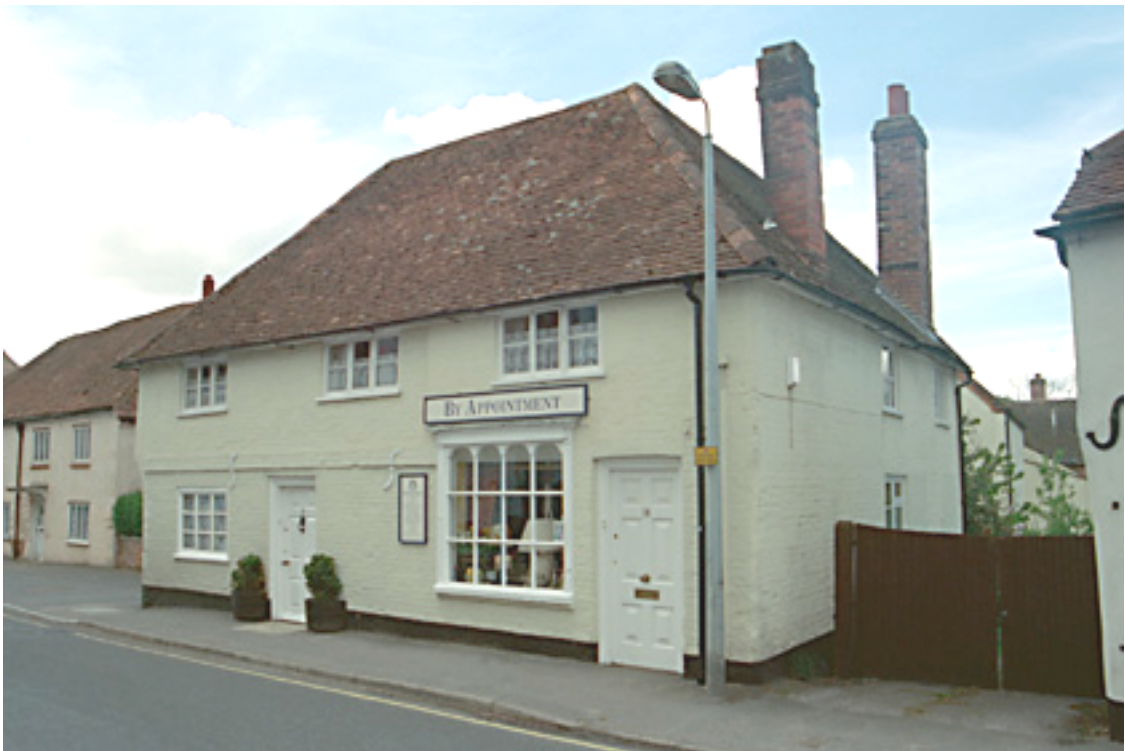
### **18 Swan Street (C S Mortimer)**

C17, C18, C19. Timber-framed house with later cladding; 2 storeys, 3 windows. Large hipped tile roof. Painted brick walling in Flemish bond, first-floor band, rubbed flat arch, plinth. Casements, the north side has a mid C19 shop window with arched lights. Six-panelled door in a solid frame, half-glazed shop door.

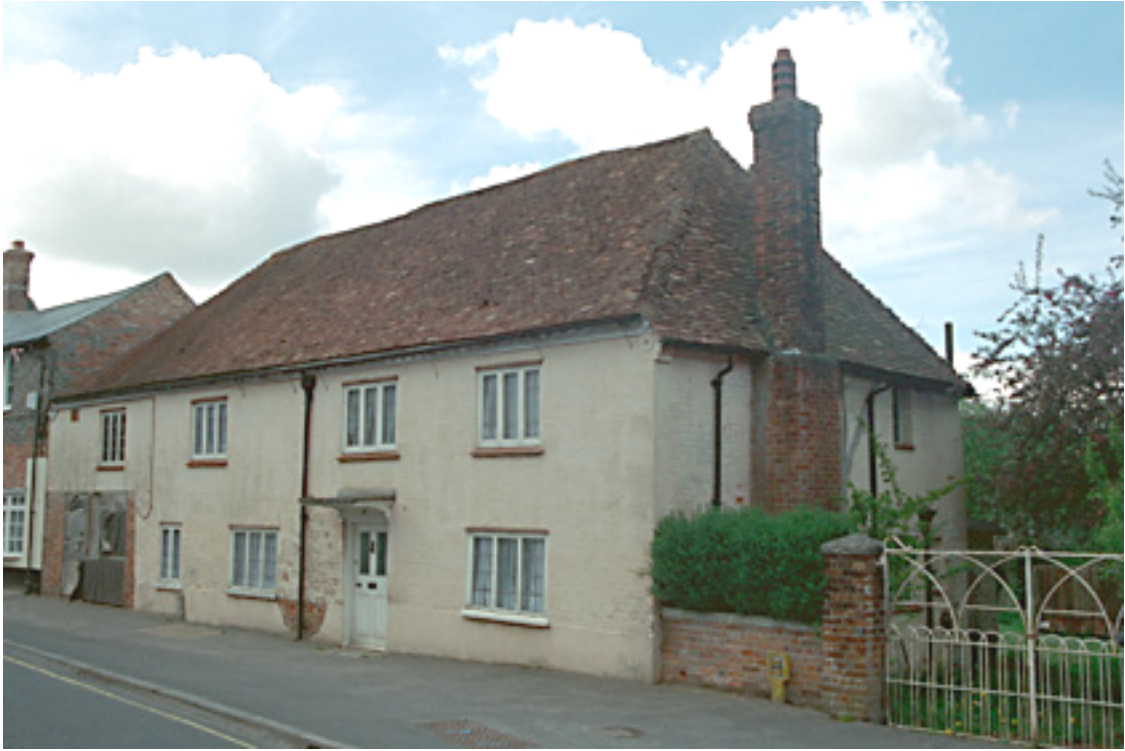
### 20 Swan Street

Late C14, C16, C18. A timber-framed 2-bay medieval hall, with a 2-bay cross-wing (solar above buttery) at the north side and a bay to the south side (now modern). The front (east) of the last date lies forward of the frame, with 2 storeys, 4 windows. Tile roof, hipped with lowered eaves at each end, brick dentil eaves. Painted brickwork in Flemish bond, cambered ground floor openings, cement plinth. Casements, half-glazed door in a solid frame, with a moulded canopy on brackets. At the south side, the ground-floor walling has been replaced by a modern section on either side of a garage entrance. Within, there is an almost complete and massive frame, the large beam above the centre of the hall has fragmentary remains of wide moulded arch braces and at the centre is a carved head; above it is an arch-braced collar; part of the arched frame of a doorway to the buttery remains. A massive chimney-breast was inserted at the time of making the first floor (of wide boards) within the hall. At the rear is a cast iron Gothic casement to an upper floor, and a modern rear extension.

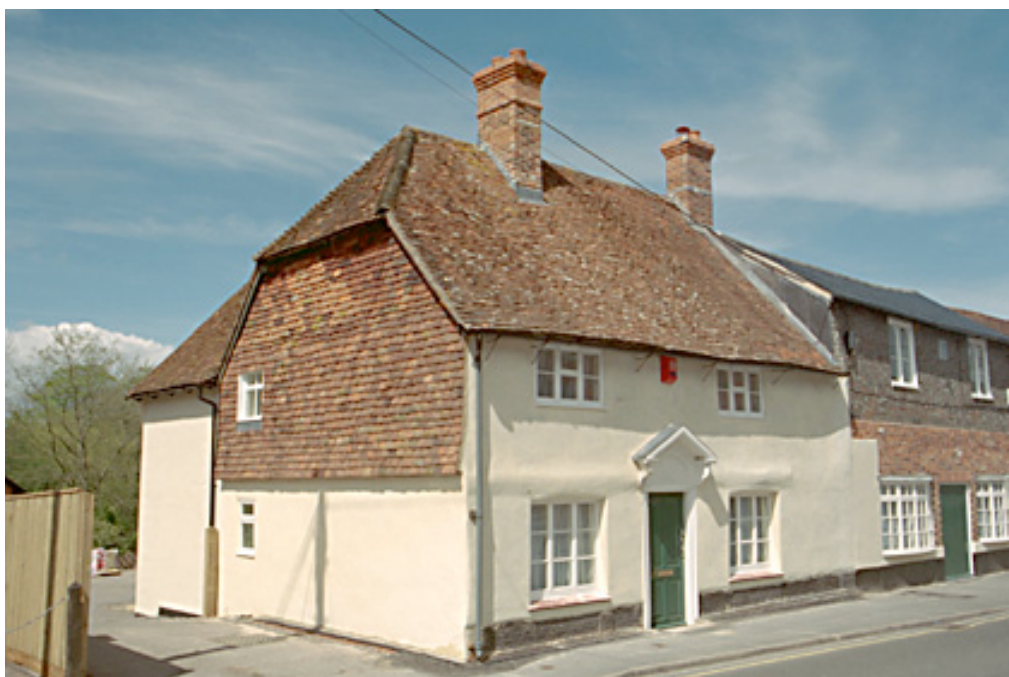
### 22 Swan Street

C18 Two storeys 2 windows Prominent tile roof hipped at the south side Rendered walling first-floor

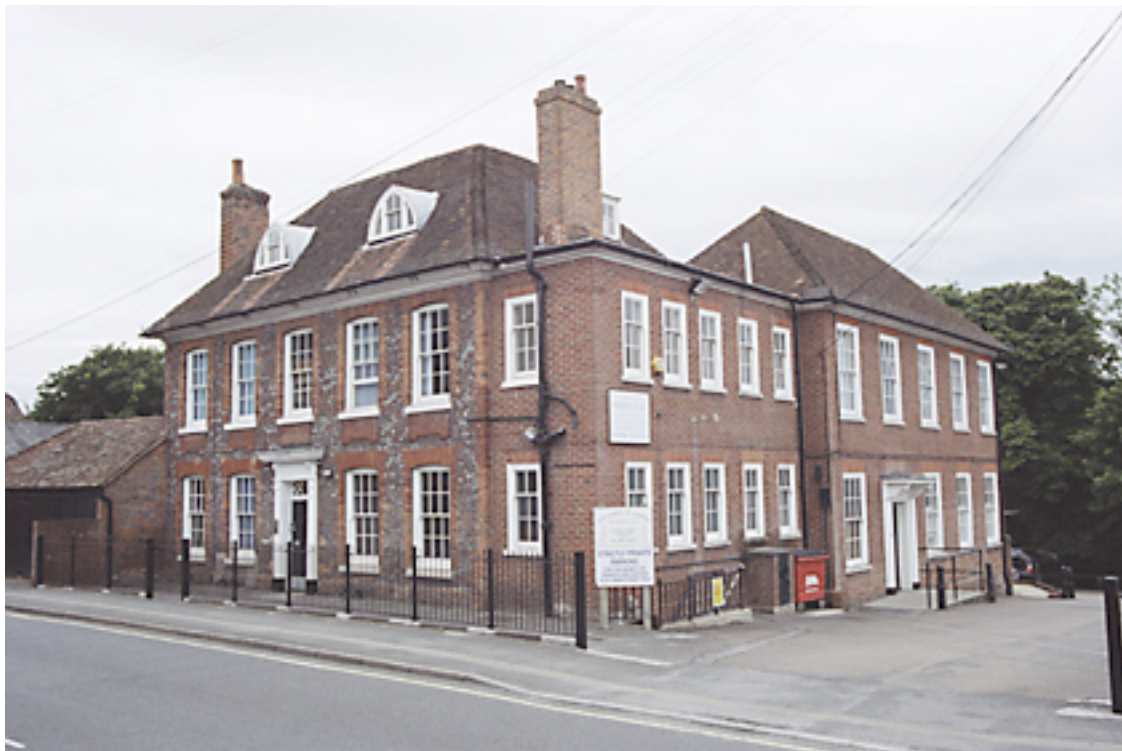
### 24 Swan Street

Formerly Offices of Kingsclere and Whitechurch Rural District Council. A Queen Anne house, with substantial additions to the rear, to form civic offices. Early C18, C20. Symmetrical front (east) of 2 storeys and attic, 5 windows. Hipped tile roof, fully-moulded wood cornice; 2 Gothic dormers of later date with pointed form, enclosing sash windows. Walling is of blue-brindle brickwork with red dressings; flush quoins and slightly-cambered rubbed arches, stone cills, aprons to the first floor, plinth. Sashes. The tall doorcase has a richly-moulded (but unorthodox) cornice, projecting at each side with grooved fret soffits, scroll brackets above fluted pilasters, panelled frieze, decorative fanlight above a modern door. Within, there is an original marble fireplace, plain dado panelling, plaster cornices, archways to the hall and upper hall, and staircase with wreathed-handrail (and masked rails). In matching style, there is a one-

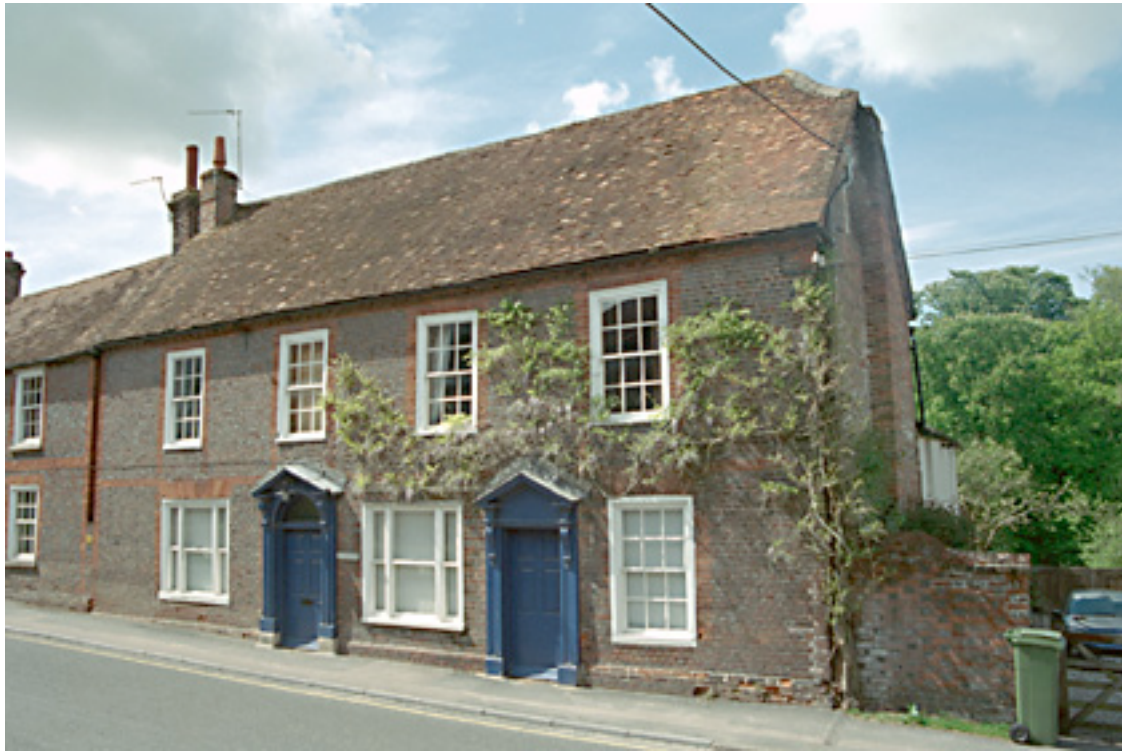
### **26 Swan Street, The Rookery**

C18. Formerly 2 dwellings, with a regular front (east) of 2 storeys, 4 windows. Tile roof, half-hipped at the north side, brick dentil eaves. Walling of blue header brickwork with red flush dressings; quoins, first-floor band, at the ground-floor one wide rubbed flat arch one Dutch arch and a modern flat arch, plinth. Sashes in exposed frames, 2 on the ground-floor being Victorian triple lights. One doorcase has an open pediment, a dentil cornice, scroll brackets above plain narrow pilasters, an arched opening (with reeded surround and impost band), a plain fanlight, and a 6-panelled door. The other doorcase, of later date, has the same classical treatment, with a square opening.

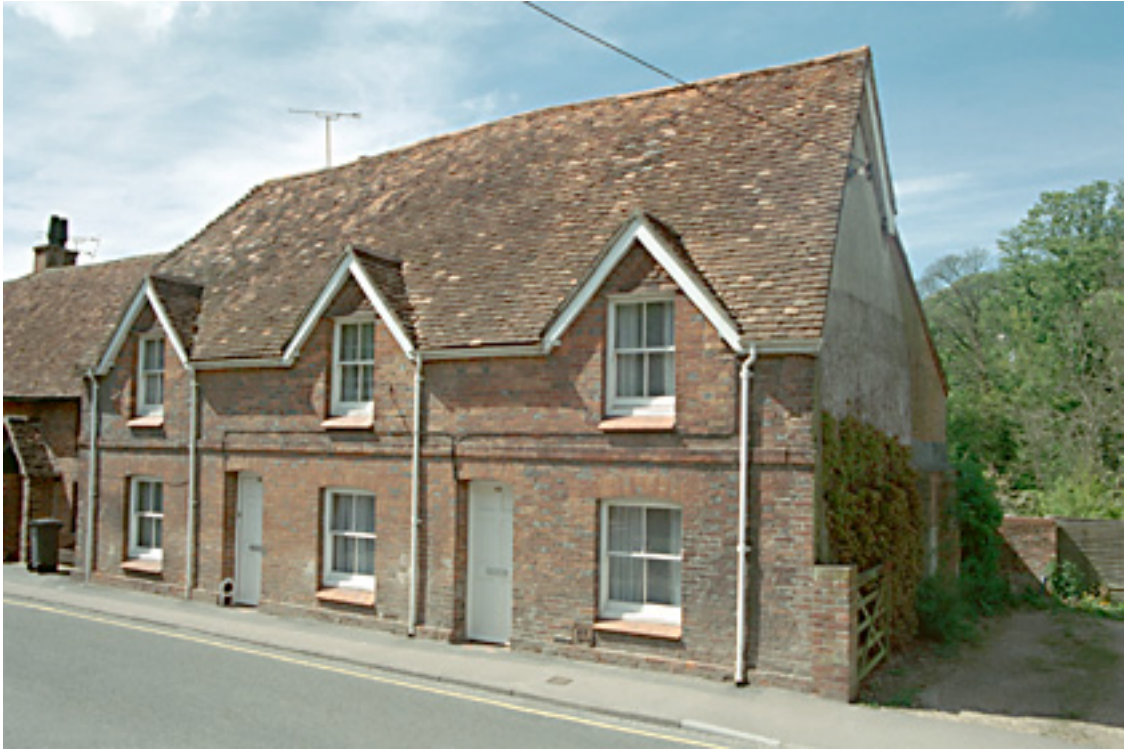
### **30 and 32 Swan Street**

Mid C19, but an older shell with C18 front wall, altered at the main date. Symmetrical front (east) of 1½ storeys, 3 windows. Tile roof half-hipped at the south side, with 3 gables (partly filled with the upper windows) with scalloped tile-hanging. Red brick walling in Flemish bond, first-floor band, plinth, and openings of the main date with cambered heads. Victorian sashes in reveals. Two plain doorways with 6-panelled doors.

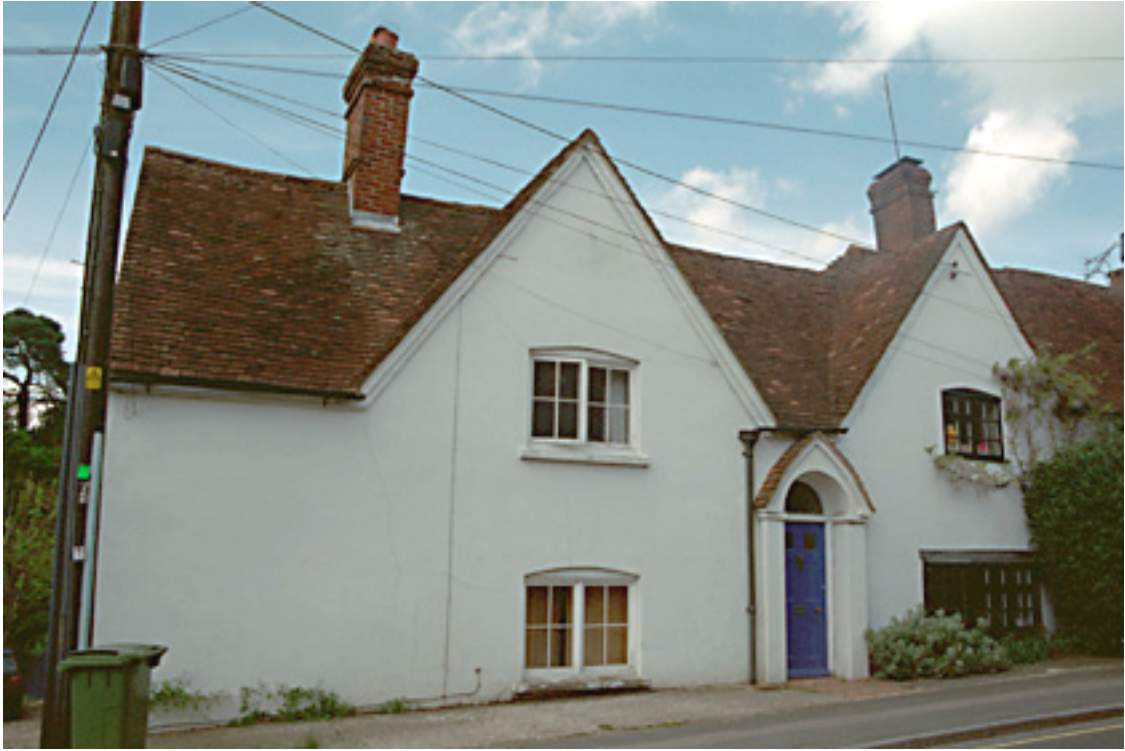
#### 42 Swan Street

C17, early C19. Formerly 2 now one dwelling; 2 storeys, 2 windows. Tile roof. Two large gables to the front. Rendered walling, cambered openings. Casements, and one modern bow. Gabled doorway with deep brick pilasters, arched opening with plain fanlight, 6-panelled (2 top glazed) door. Within, there is exposure of the timber-frame, which has some continuity with No 38.

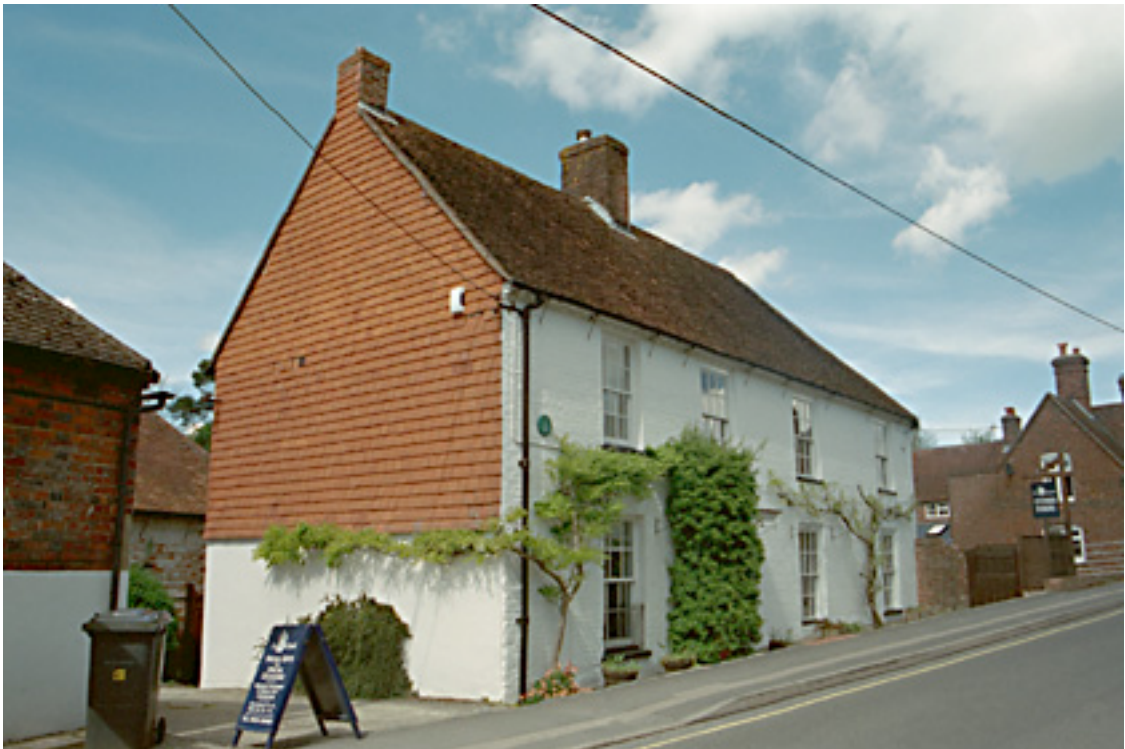
#### 46 Swan Street

C17, C18. Two storeys, 4 windows. Tile roof, with gable at the south end and hip at the north, brick dentil eaves. Painted brick walling in Flemish bond, rubbed flat arches, stone cills. Sashes in reveals. Six-flush-panelled door (2 top glazed) within a solid moulded frame, beneath a moulded canopy on decorative wrought-iron brackets. The altered walling at the west side of the north elevation has a first-floor band formed of moulded brickwork (of the earlier date).

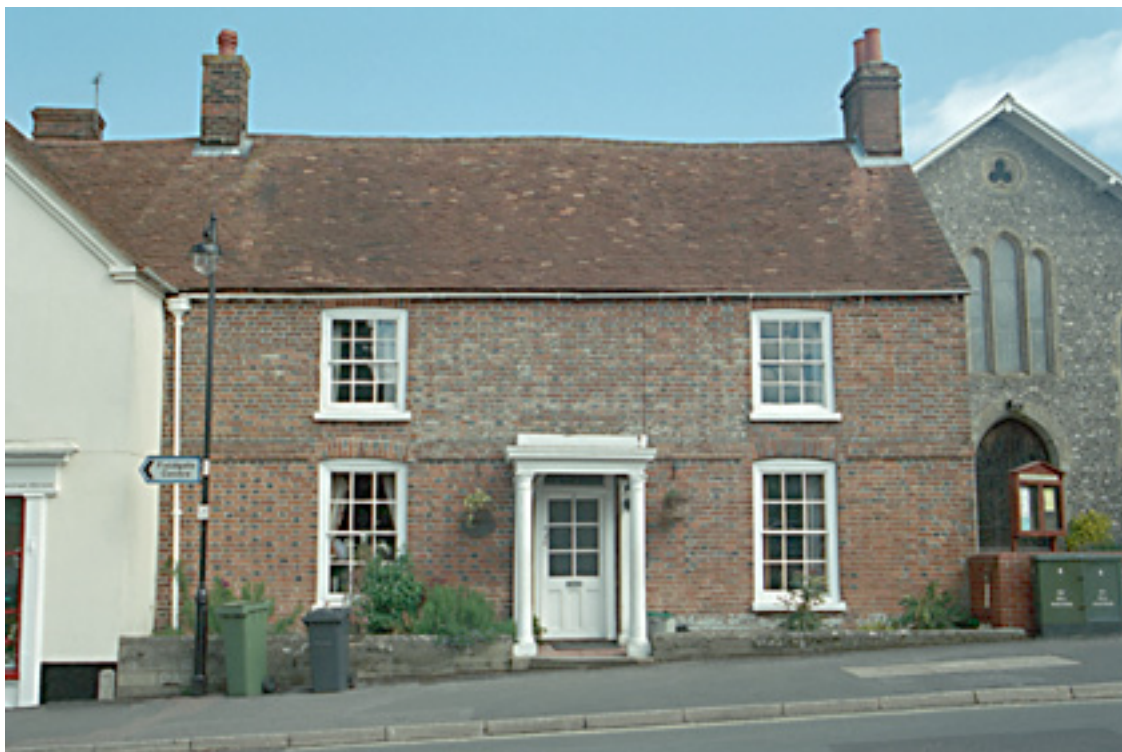
### 3 George Street

C17, C18, early C19. Symmetrical front (south) of 2 storeys, 2 windows. Tile roof. Red brick walling in Flemish bond with blue headers, first-floor band (broken by cambered ground-floor openings). Sashes in exposed frames. Tuscan stone porch of 2 columns, 2 pilasters, with half-glazed modern door beneath a fanlight. Within the house overlaps into the rear of No 1, where massive framing is shown: there are other signs of a timber-framed origin. At the rear of the east end gable (exposed to the forecourt of the

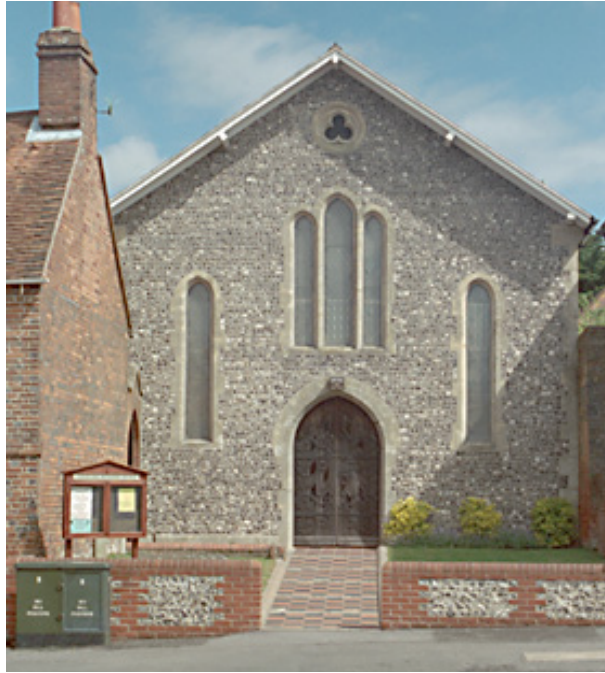
### **George Street, Methodist Chapel**

1809. Rectangular block with a symmetrical gabled front (south) to a small forecourt. Walling of squared knapped flint with flush stone dressings; quoins, a small circular panel with 3 cusps, central triple lancets (the central being taller and wider), a lancet at a lower level at each side, and central wide doorway with a pointed arch. The other sides are of brickwork, with 3 wide lancets to each long side, and a high circular window in the other (north) gable. Slate roof. Within, there is a balcony and original plain furnishings, with a number of wall monuments (of the 1850's to 90's); the 5 bays are marked by decorative roof beams. The windows are sashes. A later schoolroom (at the rear of No 3) is entered by a doorway with a pointed arch.

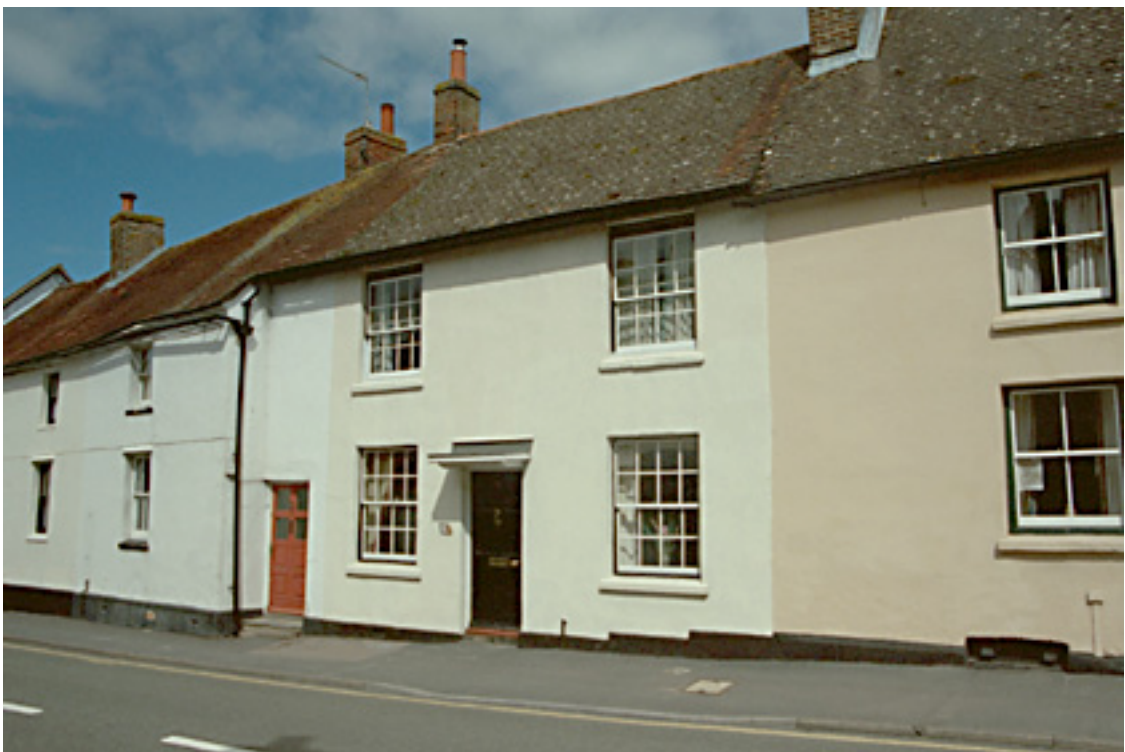
### **7 and 9 George Street**

C16, C18, C19. A timber-framed structure, with a later front; 2 storeys, 3 upper windows. Tile roof, coved plaster eaves with moulding, wrought-iron gutter brackets. Rendered walling, plinth. Victorian sashes in reveals. Stone oval-arched canopy on brackets to No 7, canopy to No 9, boarded doors in solid frames. Within, the framing is exposed, including a cruck, and there is a massive chimney breast with a moulded bressumer. The west side ground-floor windows replace a carriage entrance (to a former fire-station).

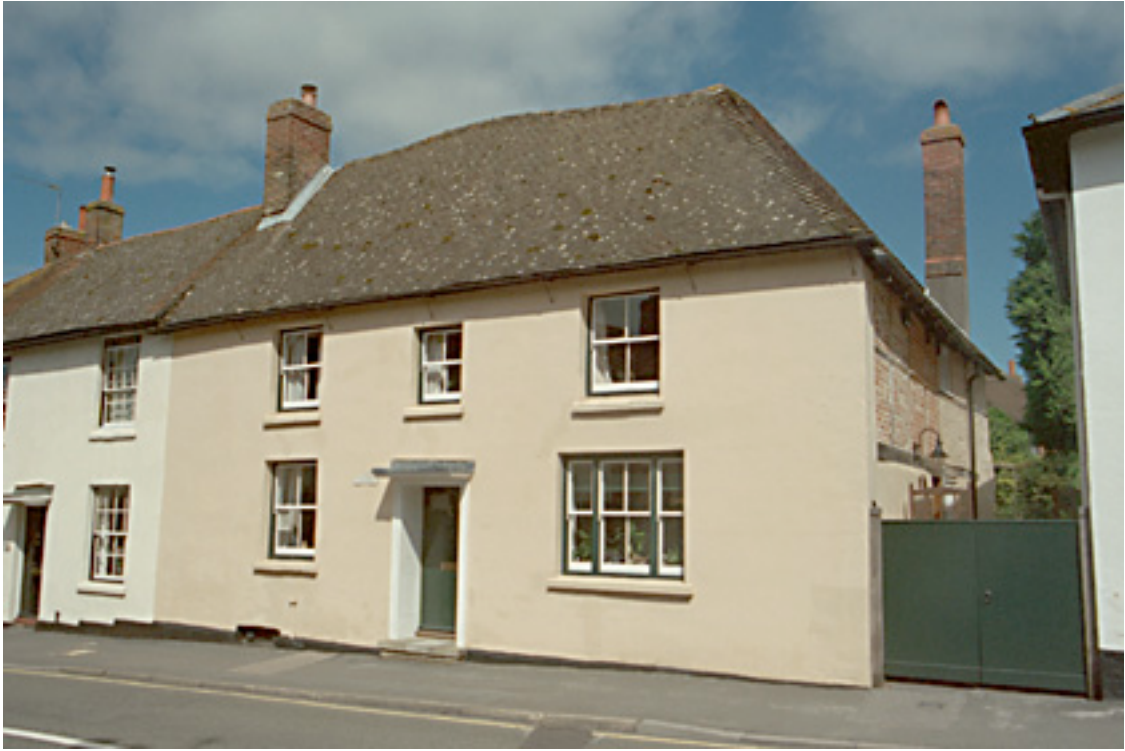
### **11 George Street**

Early C19. Two storeys, 2 windows. Modern tile roof. Rendered walling, stone cills. Sashes in reveals. Plain doorway with a canopy on brackets, and a carriage entrance at the east side. Probably timber-frame within.
