## Kingsclere

- a village with 95 listed buildings

Chris Watkins

2020

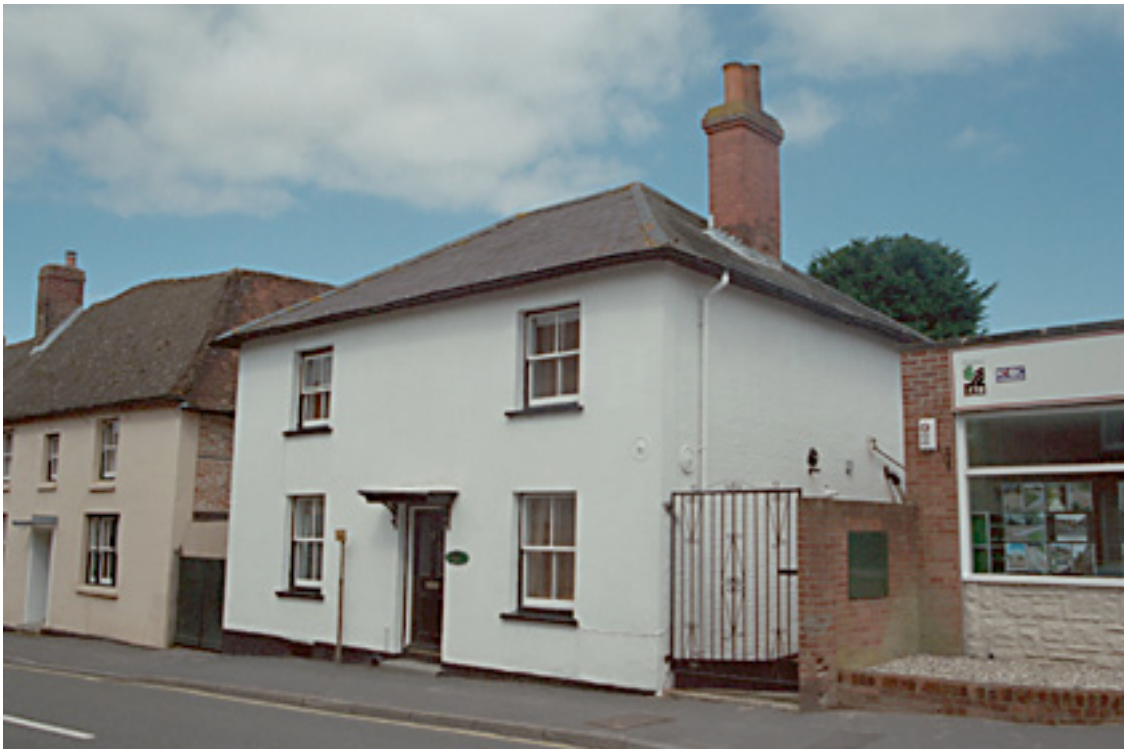
### 13 George Street

C16, C17, C19. Two storeys, 3 windows. The east side has a late-medieval timber-frame of 2 bays at right angles to the road, with rear half-hipped gable, the front (gable) now embodied in a hipped roof; the west side is timber-framed of a later period. Large tile roof. Rendered front wall; some framing exposed at the rear and north sides, with painted brick infilling, plinth. Victorian sashes in reveals, one ground floor modern bow. A 6-flush panelled door in a solid frame has a thin canopy on brackets. The massive framework is exposed within.

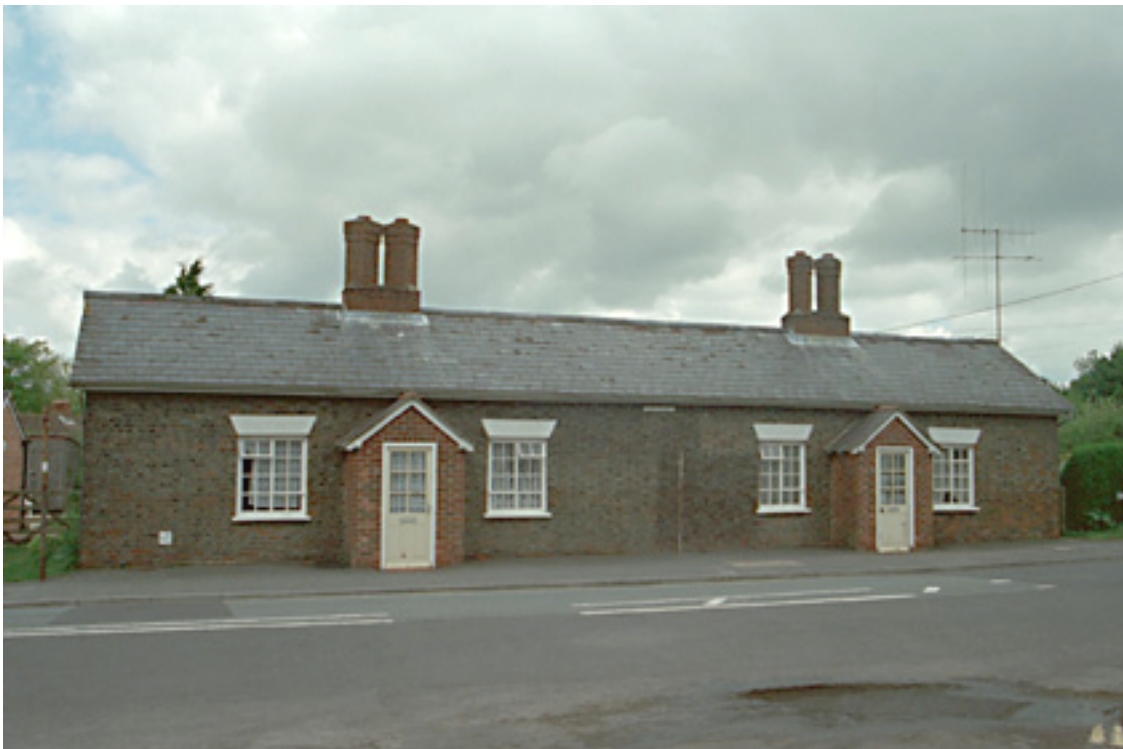
### **35 and 37 George Street**

Tablet incised TB 1832. A short terrace of 2 storeys, 5 windows. Slate roof. Blue brick walling in header bond, Dutch flat arches to the ground-floor, stone cills. Sashes (of 16 lights) in reveals. The entrance to each is a Tuscan porch, with smooth columns and pilasters, and half-glazed doors.

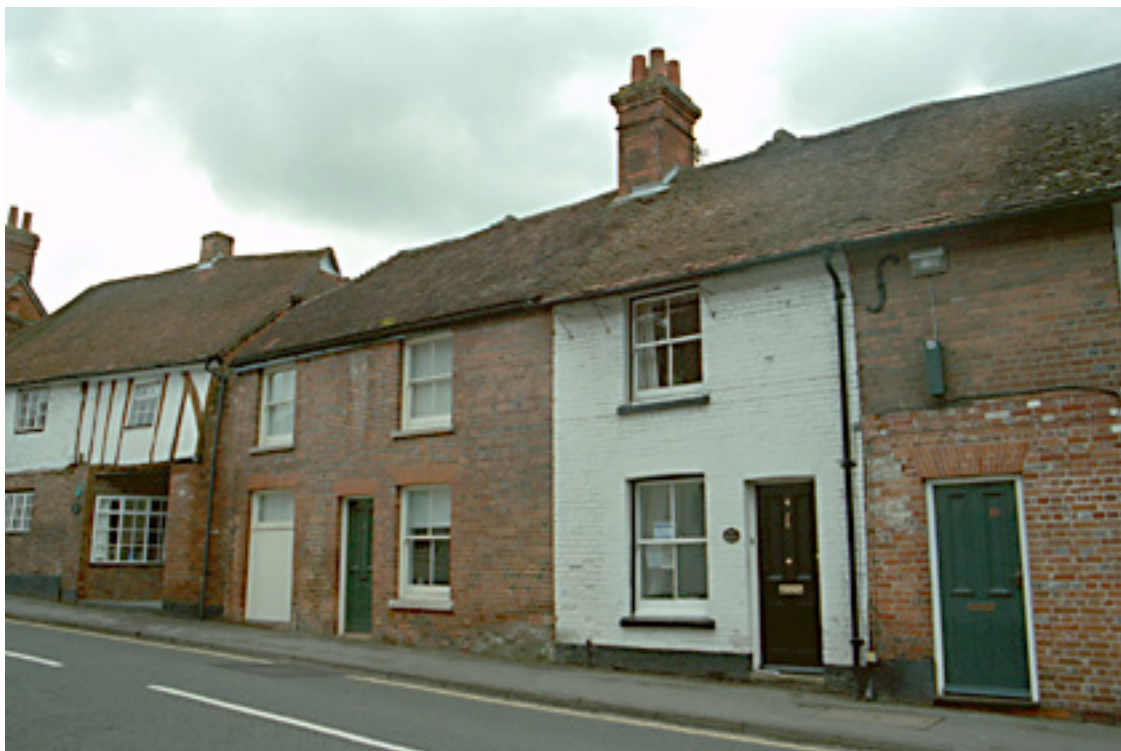
### **2 George Street**

C16, C17, C18 early C19. Two-storeyed terrace, with internal timber-framing of varied survival, and external brick walling of C18, early C19 period. Tile roof, hipped at the corner; there is a large stack with a Tudor base and 3 modern diagonal flues. Walling of brickwork, of English bond and also Flemish bond with blue headers, first floor band, rubbed flat arches and one cambered arch, plinth. A mixture of sash windows, C18 early C19, and modern. The main doorway (C18) has a moulded canopy with panelled soffit, carved brackets above panelled pilasters and a plain fanlight, with a later addition of slender Gothic columns (of wrought-iron). Within, the west end is 2-bay timber-frame still gabled to the rear, and the massive stack was attached to its north side; on the first-floor there is a stone Tudor fireplace with a moulded 4-centred arch.

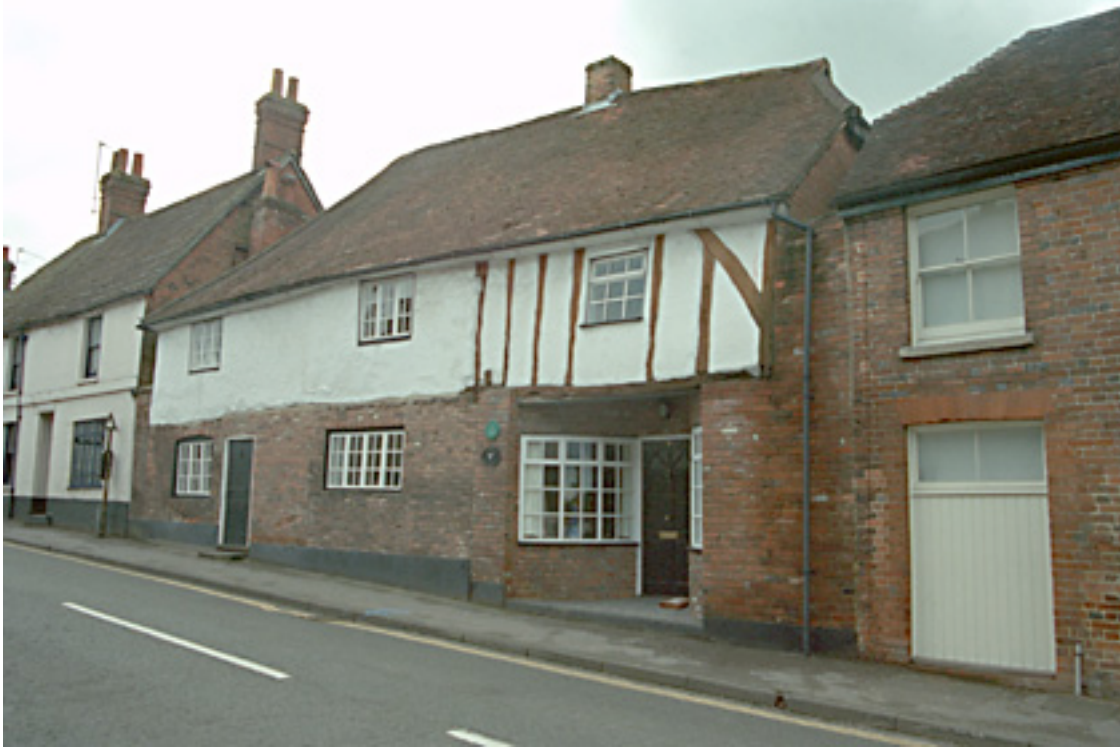
### **4 and 6 George Street**

Old 2-storeyed terrace with a mid C19 front (north) to the street, of 1-2 windows. Tiled roof. Walling of red brickwork in English bond, with some blue headers, rubbed flat arches (to No 6). Victorian sashes in

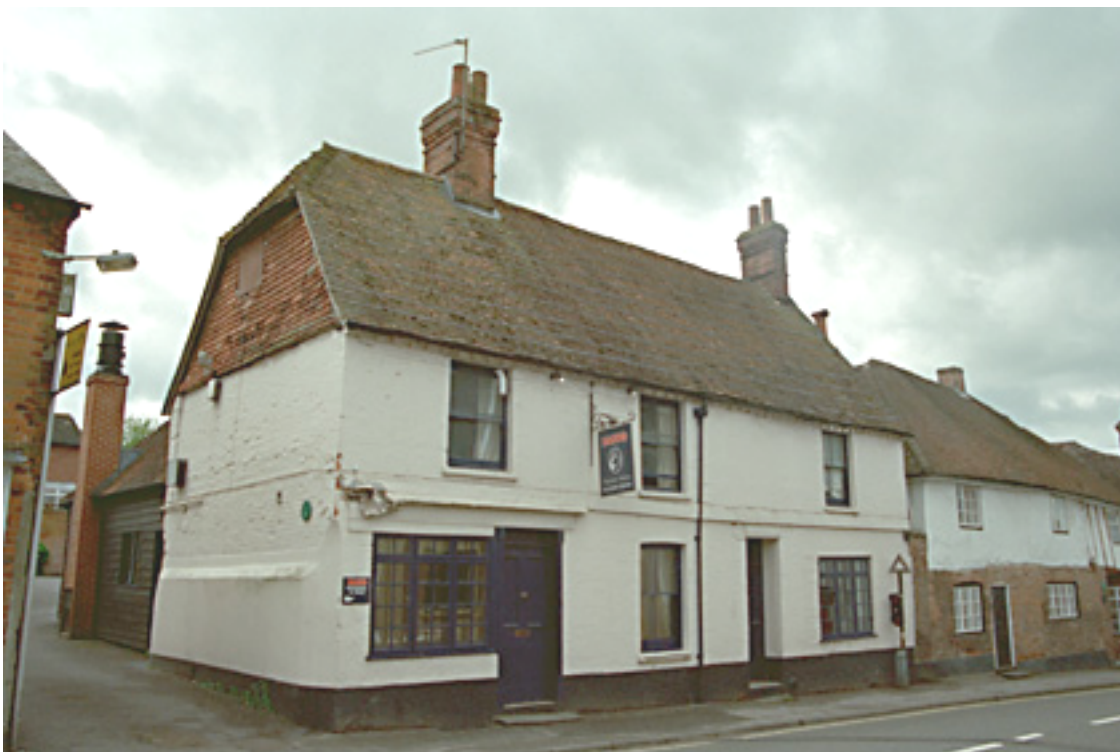
### 8 George Street “The Olde Forge”

C15, C18, C19. Late medieval 3-bay (central hall?) timber-frame, mostly surviving above the ground-floor, with details of the later periods; now with a front (north) of 2 storeys, 2 windows. Large tile roof, hipped at the east, half-hipped at the west end. The upper walling is plastered, the ground-floor of painted brickwork. Casements of varied form. Plain doorway with a simple canopy; the west side has a wide opening (to the forge) with half-glazed folding doors. Within these are massive beams and a large chimney breast: also a fine C18 oak corner cupboard with a curved front.

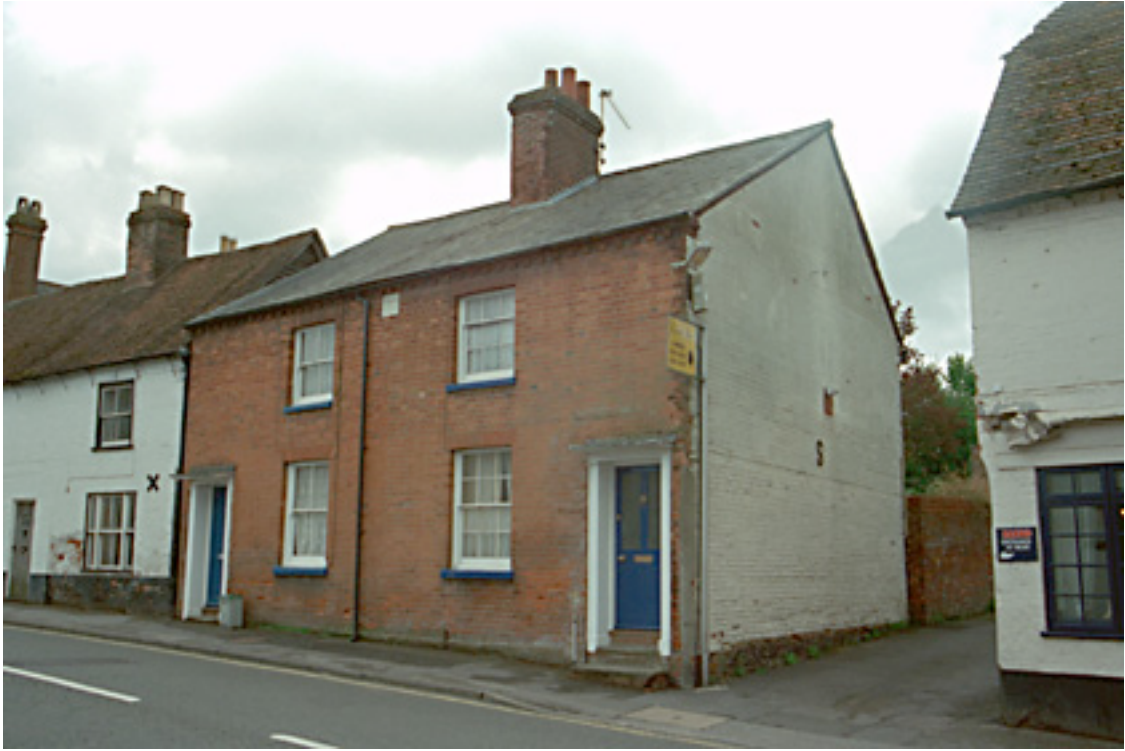
### 10 and 12 George Street

C18. Two storeys and attic, 3 windows. Tile roof, half-hipped at the east end above a tile-hung wall; brick dentil eaves. Walling of painted brickwork in Flemish bond, first-floor band, one former window now fitted. Victorian sashes; enlarged windows (shop fronts) to the ground-floor. One plain doorway with a

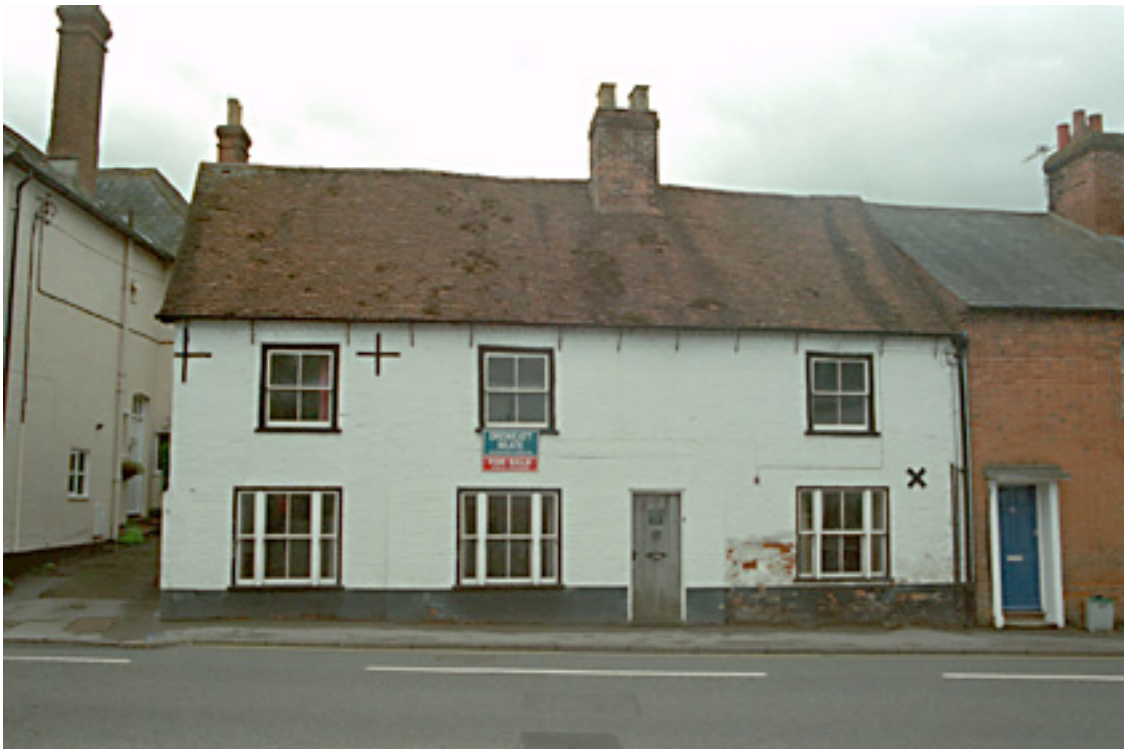
#### **14 and 16 George Street**

1821. A symmetrical pair, of 2 storeys, 2 windows. Slate roof, brick dentil eaves. Red brick walling in Flemish bond, rubbed flat arches. Sashes in reveals (old to No 14). Simple doorways with small hoods. Central stone plaque inscribed J Roake 1821.

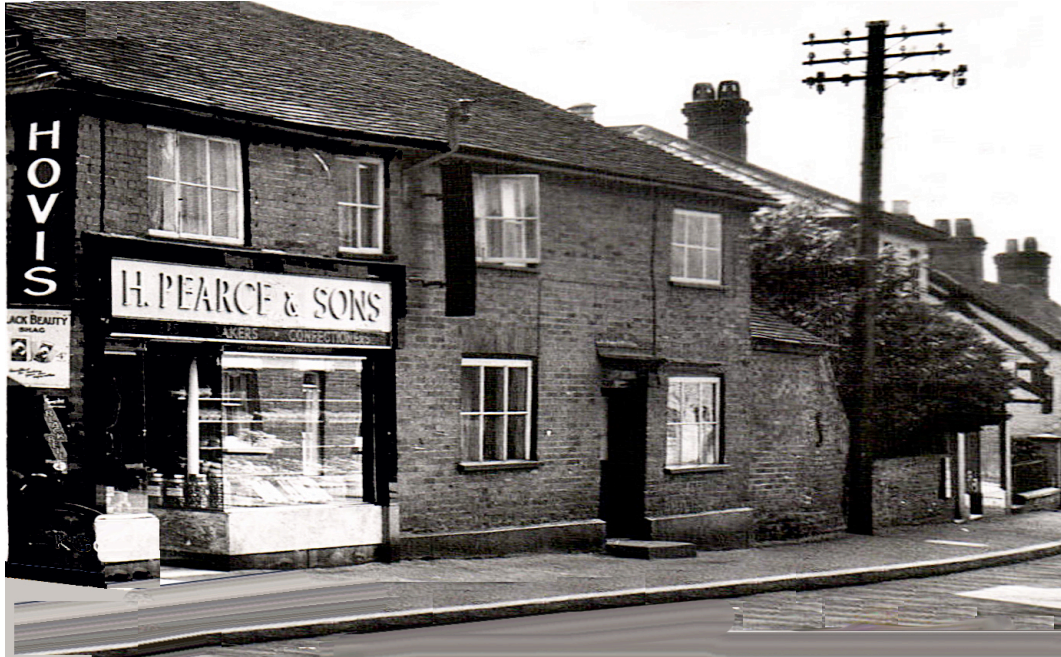
### 22 George Street

Late C18 exterior to older building; house and shop. South front of 2 storeys, 4 upper windows. Tile roof, hipped to the north and above rear extensions, brick dentil eaves. Red brick walling in Flemish bond, rubbed flat arches, cement plinth; the north side has older brickwork (painted) in English bond. Modern casements. Old doorframe with a modern door; modern shopfront at the east side.

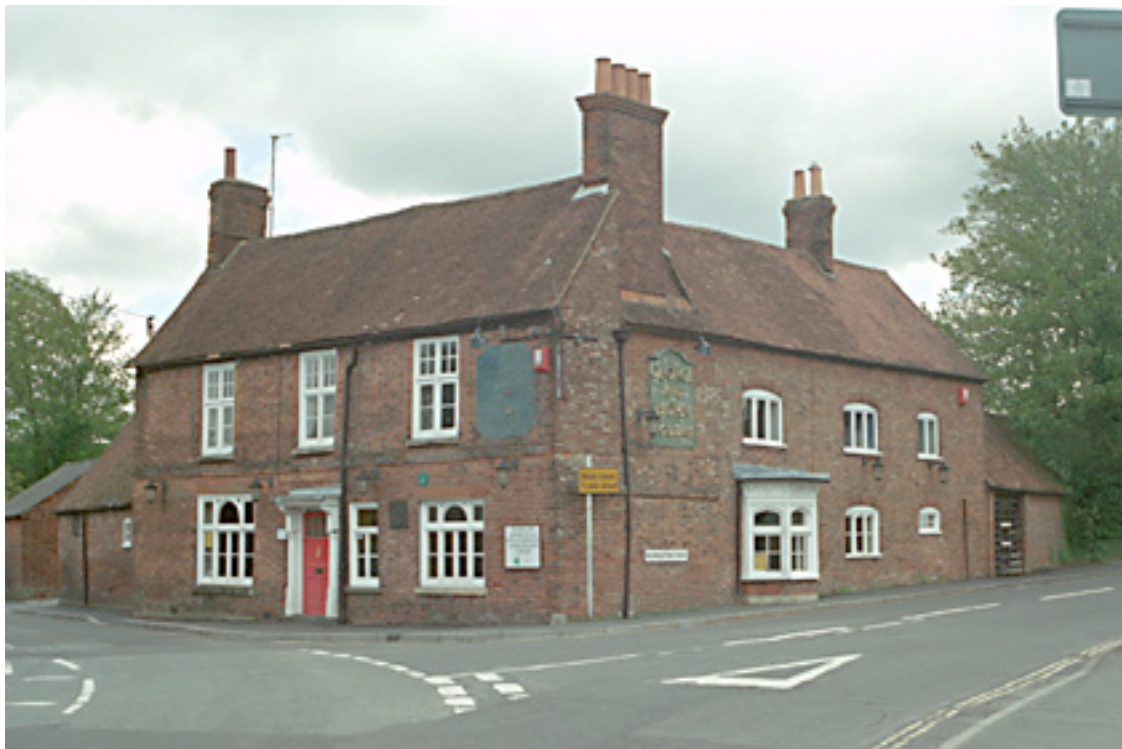
### George Street, George and Horne Public House

C17, C18, C19. Two-storeyed L-shaped corner block, with extensions of the later period. Symmetrical front (west) of 3 windows. Tiled roof, moulded plaster eaves. Brick walling in Flemish bond, red with blue headers and red quoins above a first-floor band (which is red with a blue central band), red to the ground-floor, rubbed flat arches, plinth; some exposed timber-framing at the rear. C19 mullion and transom windows, and C19 doorway. The eaves at the corner carry a wrought-iron sign bracket. The south elevation has cambered openings with casements, and one angular bay with a large cornice on brackets. Beyond the main block, in each direction, are single-storied extensions, with tile roofing and red brick walling with blue headers.

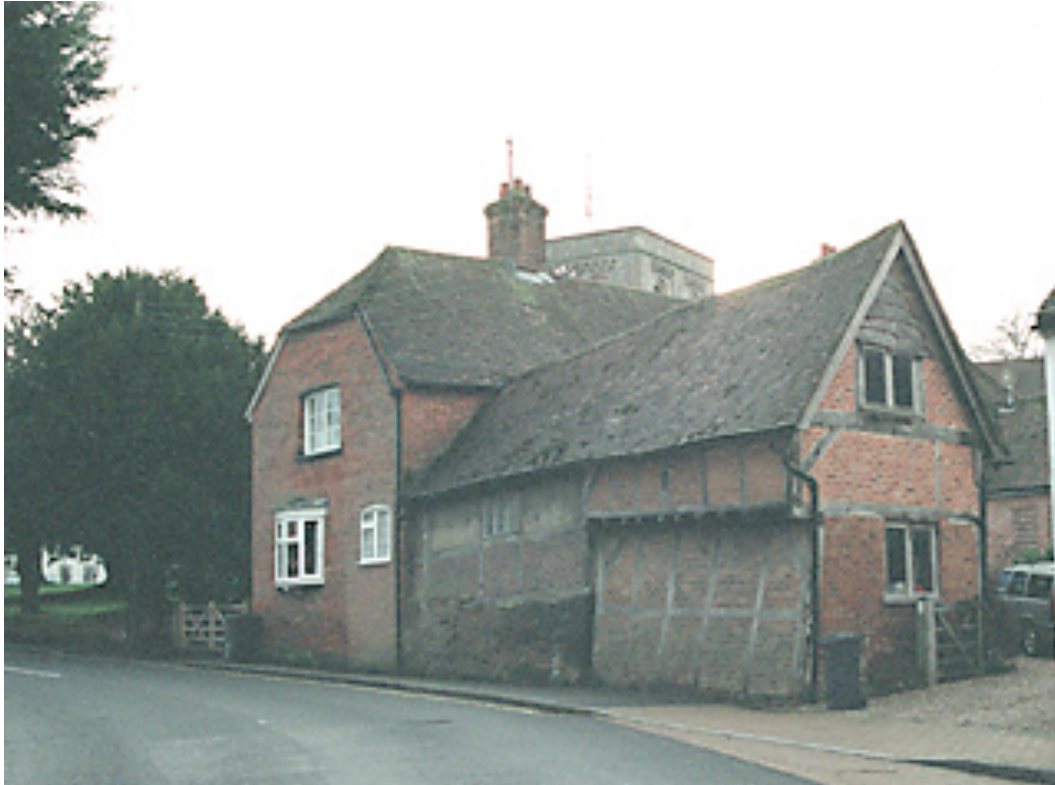
**1 Newbury Road, Falcon Inn and barn**

C16, C17, mid C19. Formerly the Falcon Inn; a timber-framed house with lower wings to the rear at each end, with recladding of the main block at the last period. Two storeys, regular east elevation of 4 windows. Tile roof, hipped at the south and south-west, half-hipped at the north, gabled north wing, catslide at the rear. Red brick walling in Flemish bond; the north wing (prominent alongside Newbury Road) has bricknogged timber-framing, with a jetty to the end part (barn or malthouse), roughcast on the south side. Victorian 3-light sashes to the east front, otherwise casements. Glazed front door.

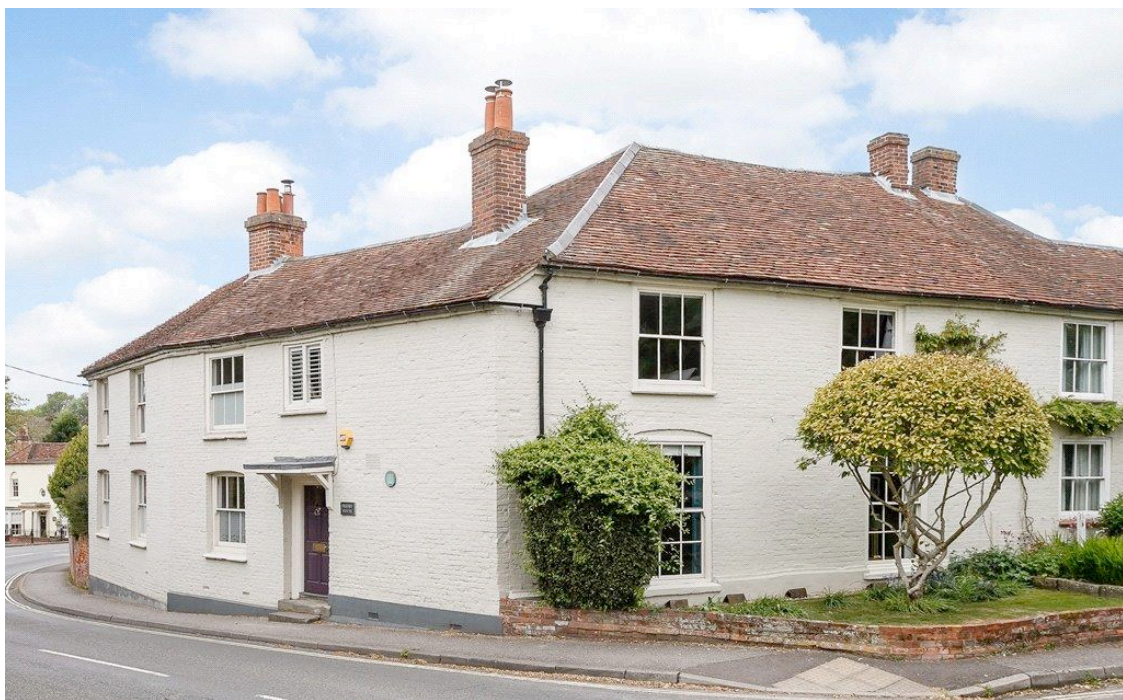
**2 Newbury Road, Priory House (and Priory Cottage)**

C15, C18, early C19. Two-storeyed L-shaped block. A 3-bay medieval timber-frame, with central open hall; the western arm starts as a (C17) timber-frame but continues as a C19 extension, the northern arm is also C19. The 2 fronts have 2 storeys, 2:2:2:2 windows. Hipped tile roofing, taller to the middle section, which has a catslide at the rear. Walling of painted brickwork in Flemish bond, slightly-cambered ground-floor openings, cement plinth. Each doorway has a 6-panelled door in a solid frame, beneath a moulded canopy. The interior has exposure of the massive timber-frame and the corner ground-floor room has

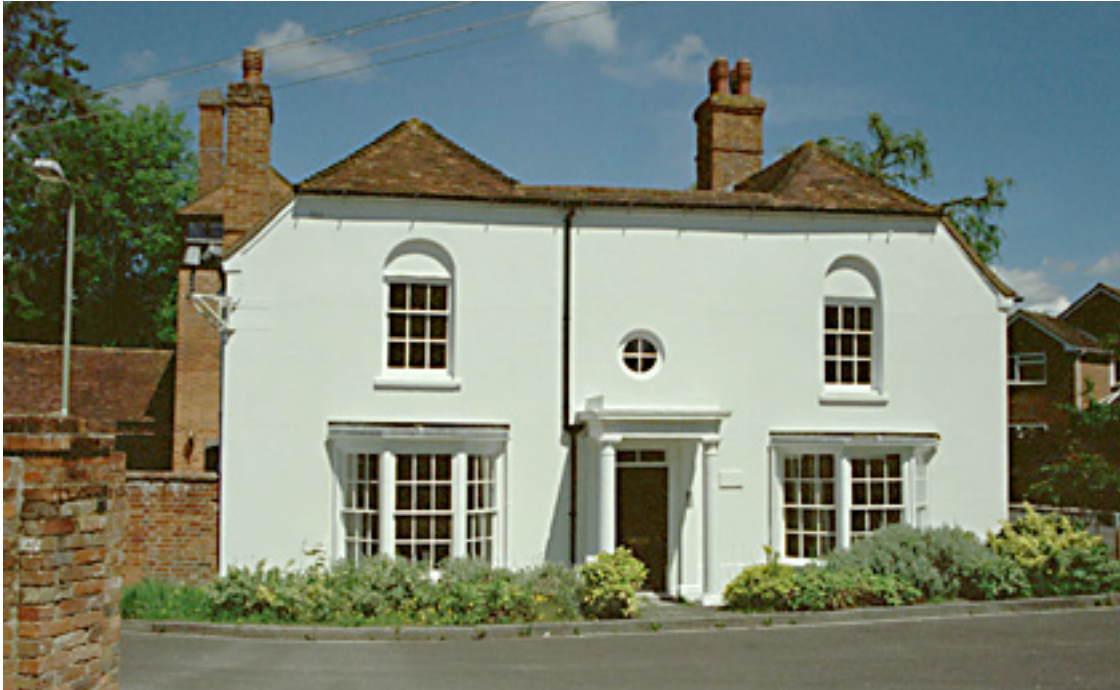
### **5 Newbury Road, Old Brewery House**

C15, late C18, C19. Symmetrical front C18, of 2 storeys, 3 windows. Tile roof, having former gables now half-hipped with a parapet between, hiding the valley. Rendered walling, plinth. The upper windows on each side are sashes beneath an arched opening, in the centre is a small circular window, at the ground-floor are angular bays with sashes and flat roofs. The entrance is a Tuscan porch of 2 columns 2 pilasters, with a plain fanlight and 6-panelled (2 top glazed) door. The building extends to the rear with modern details; behind the wall is a cruck which indicates a former timber-frame. Within, there are panelled doors in architraves, an early C19 stair, a fireplace with a cornice above a surround having a bolection moulding.

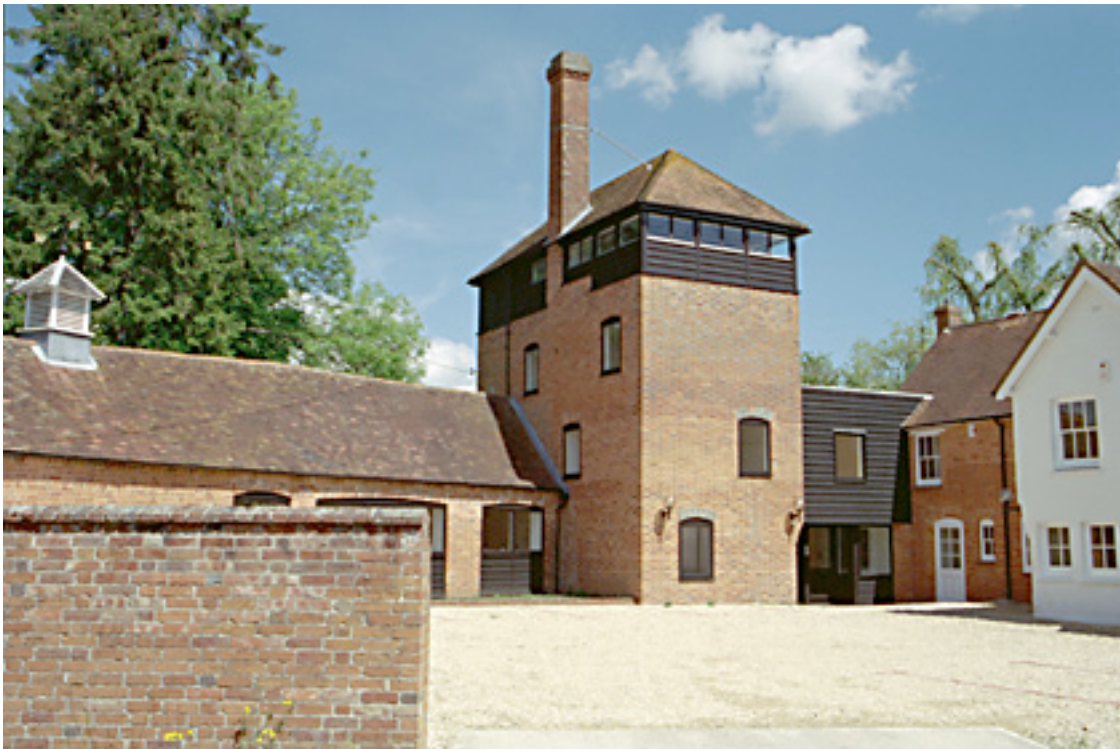
### **The Brewery Buildings, Newbury Road**

C19. A range of buildings, of 2 storeys next to the house, then a tower, and long single-storeyed range, all facing a yard. Tile roofing, hipped. Red brick walling in Flemish Garden Wall bond, the top floor of the tower being boarded, with louvred sections. Within, there are brick oven structures and heavy timbers.

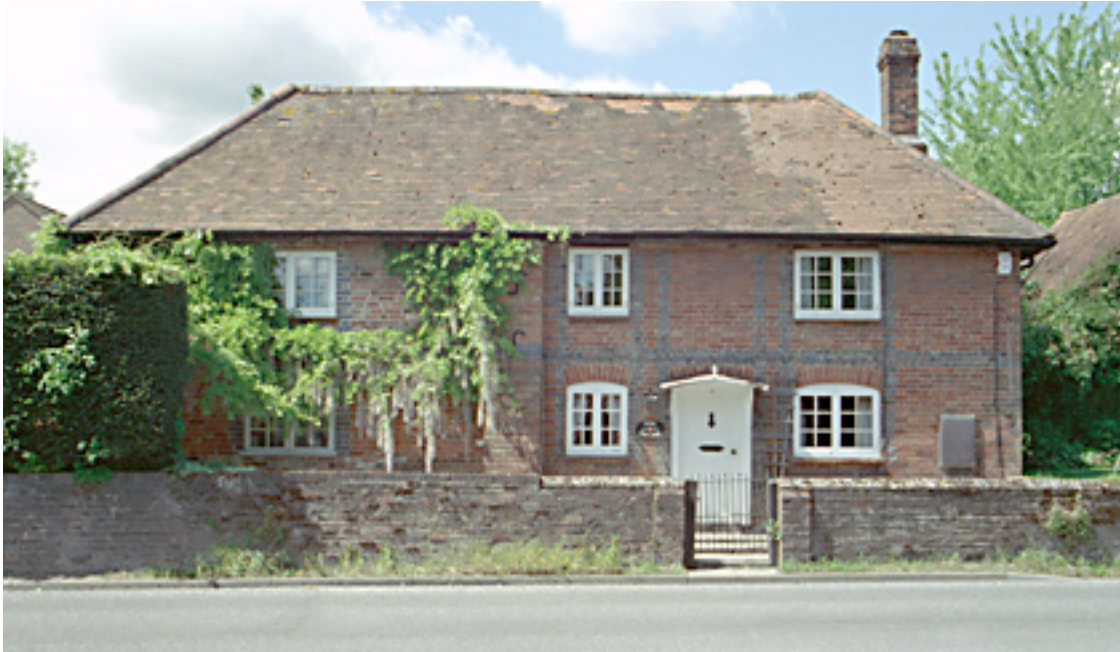
### **7 Newbury Road**

Early C19. Cottage with some internal timber-framing, but with a front (east) of the main period, and a modern extension to the south side in matching style; 2 storeys, 3 windows. Hipped tile roof. Red brick walling in Flemish bond, with flush blue first floor band and vertical strips on each side of the openings. Casements. Boarded door in a solid frame beneath a simple pediment canopy on brackets. Modernised.

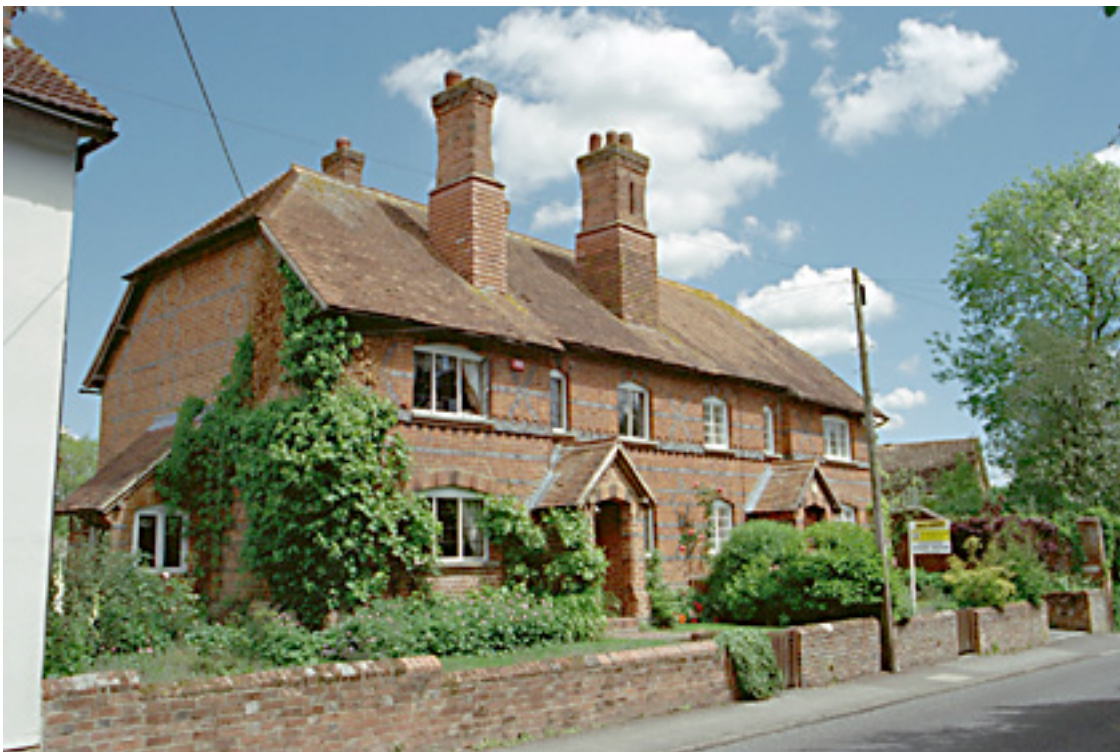
### **8, 10 and 12 Newbury Road Tower Hill Cottages**

Mid C19. Butterfield style block of 4 (eastern 2 now one) cottages, with a symmetrical front of 2 storeys, 1.4.1 windows. Tile roofing, half-hipped at ends, with a lower eaves to the slightly projecting sides; tall brick stacks with tile-hung lower parts. Red brick walling in Flemish bond, with several flush blue bands, the upper band intersected by diapers, first floor projecting blue band with recessed blue headers above and below, angular openings with patterns of dark brick voussoirs, plinth. Three-light casements with cast-iron windows, having Gothic heads; stone cills. Gabled brick porches to Nos 8 and 10. The west gable shows 4 vertical blue diaper patterns intersecting horizontal bands, with a central brick porch with a single-pitched roof and side doorway (facing the front); the east gable is similar but the porch has been

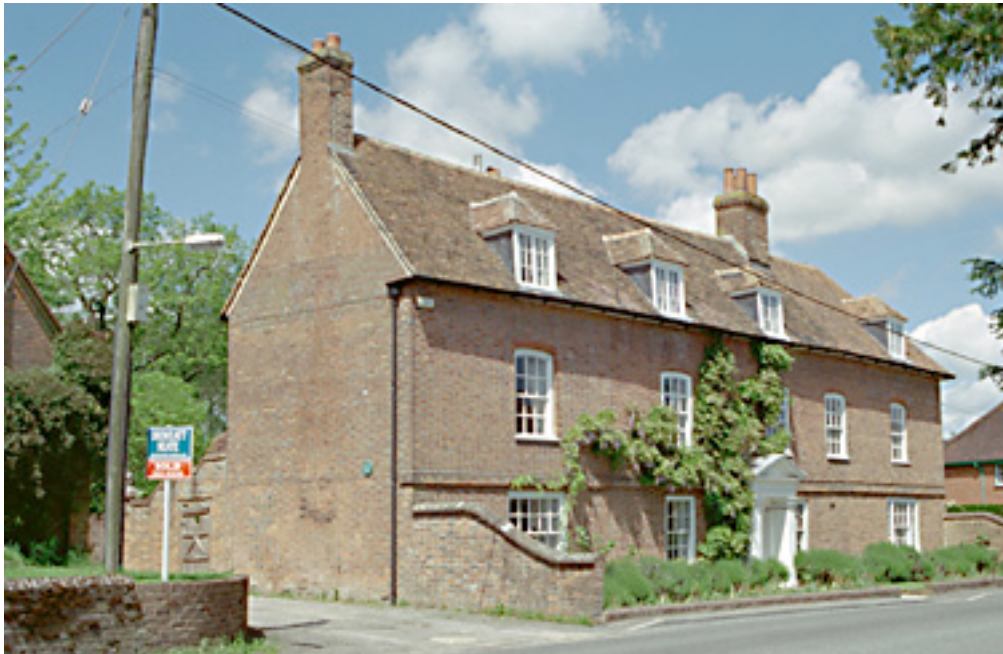
### **9 Newbury Road, The Old House**

May have been the Manor House: a large building of 2 storeys and attic, with a substantial timber-framed core. C17, 1684, early C19. A regular front with some altered openings; 5 tipper windows. Tiled roof, hipped at the north side; 4 hipped dormers with casements. Red brick walling in Flemish and also English bond, with blue headers, slightly-cambered upper openings, first floor band, 2 rubbed flat arches to the ground-floor with later wider openings at each side, plinth. Sash windows; 4 of the early C18, the others late C18 (2 wider windows at each side). Stucco doorframe (early C19) of simple Tuscan Order, with pediment, wide and deep pilasters, on a stone step, the 6-panelled (2-top glazed) door being within an architrave. Carved brick date plaque (1684) in a chamfered recess, below the eaves in the centre of the front. Within, there is a massive fireplace of the early date.

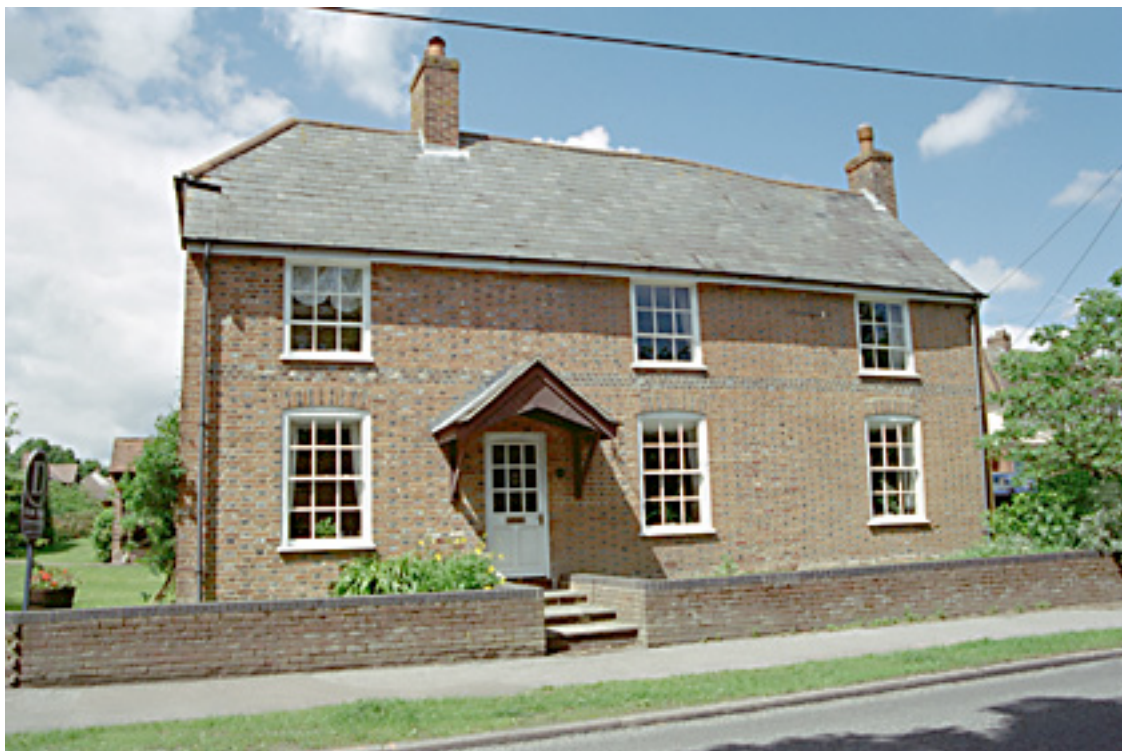
### **25 Newbury Road**

Early C19 Two storeys, 3 windows. Steep slate roof, half-hipped at the south end, with tiling above the rear extension. Red brick walling in Flemish bond, with blue headers, blue flush first-floor band, red quoins, cambered ground-floor openings with 2-coloured heads. Sashes in exposed frames. Moulded

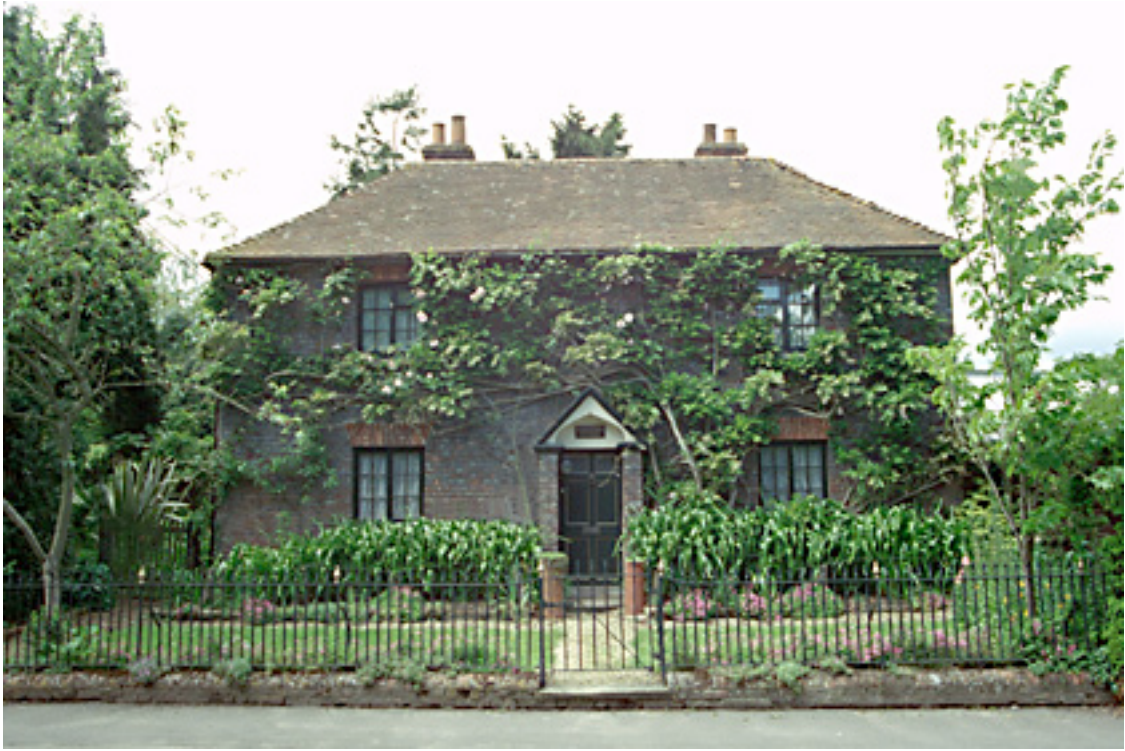
### **Goldfinch Cottage , Newbury Road**

Mid C19. Symmetrical front (east) of 2 storeys, 2 windows. Hipped tile roof. Walling of blue brickwork in Flemish bond, with red rubbed flat arches, stone cills, plinth. Modern casements. Shallow gabled porch with a Gothic arch, plastered Tympanum, and 6-panelled (2 top glazed) door. The south elevation is completely hung with scalloped tiles and has a similar porch (now a window) to a former second dwelling.

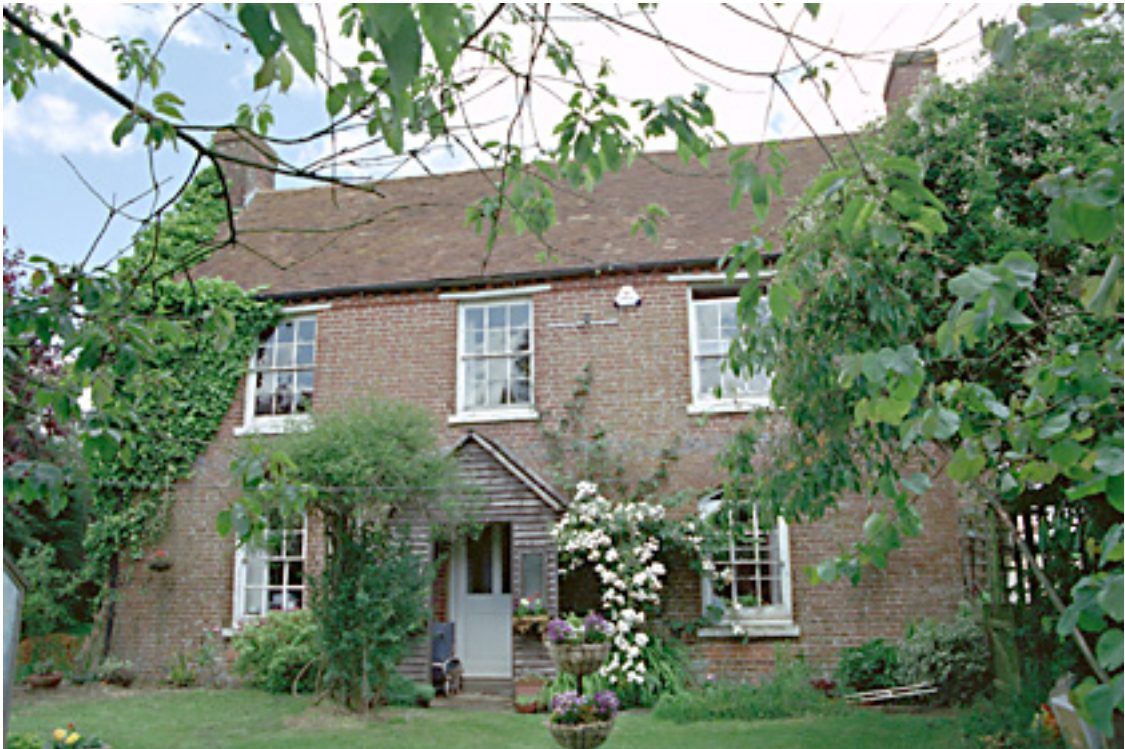
### **Coldridges Farmhouse, Newbury Road**

Late C18, C20. Symmetrical front (south) of 2 storeys, 3 windows. Tile roof, brick dentil eaves. Red brick walling in Flemish bond, flush blue headers; first floor band, rubbed cambered arches to the ground-floor. Sashes in reveals. Half-glazed door in solid frame. There is a recent 2-storeyed extension at the rear, with a pantile roof replacing the former catslide.

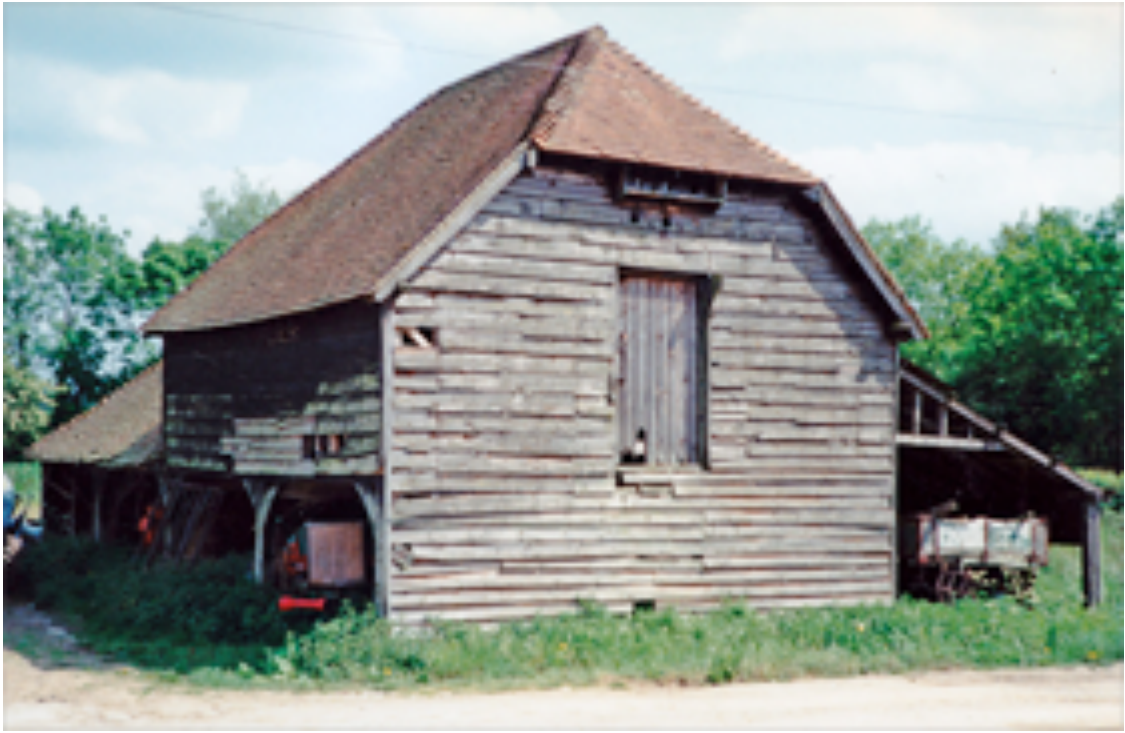
### **barn at Coldridges Farmhouse, Newbury Road**

Early C18. Timber-frame of 7 bays with projecting central entrance: Queen post truss. Roof of corrugated asbestos, hipped at ends. Boarded walling above a brick base. Lower extensions of recent date.

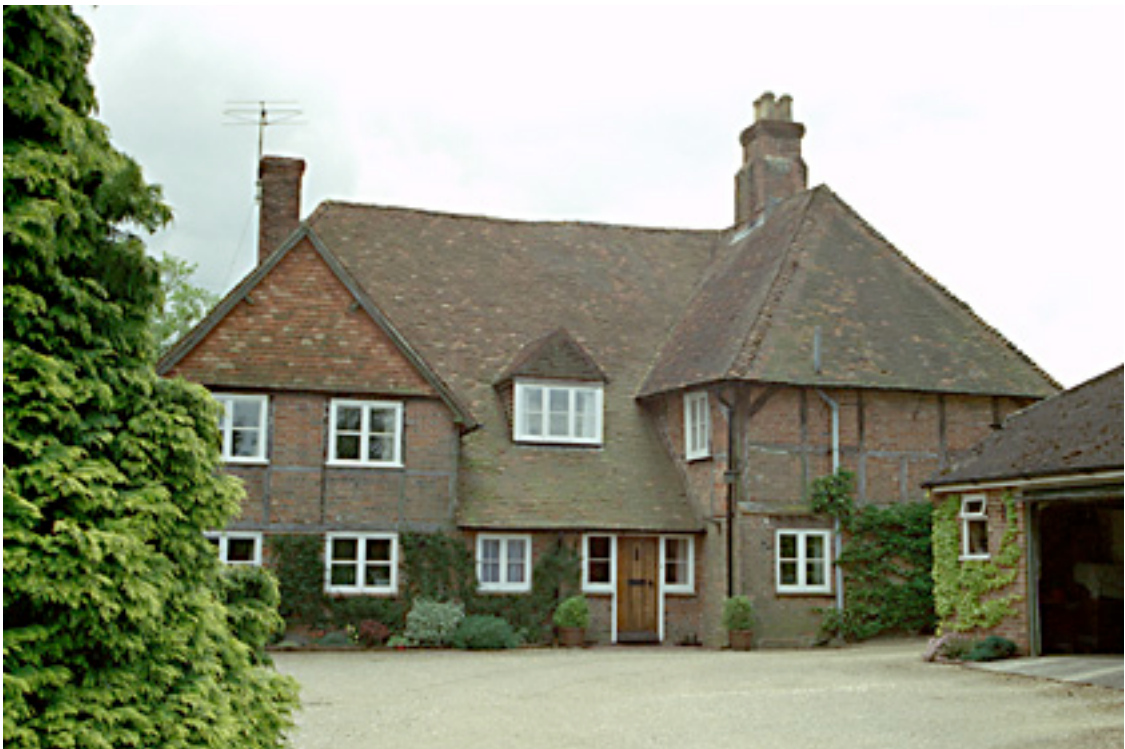
### **Porch Farmhouse, Newbury Road**

C17, C18, and C20. Timber-framed house with later extensions; 2 storeys, irregular fenestration. Hipped tile roof: recent tile-hung gable. Shafted stack. The bricknogged frame is exposed on the east and north elevations, other walling being of red brickwork, with some rendering on the south side. Casements. Recent doorway.

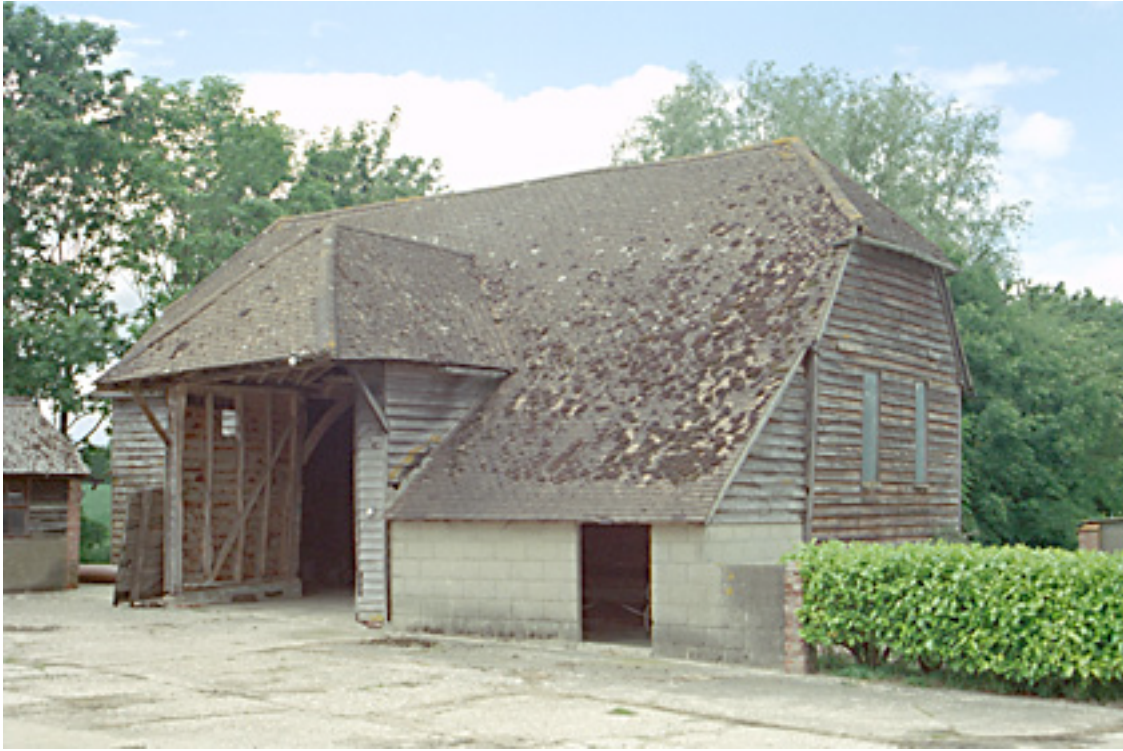
#### **barn at Porch Farmhouse, Newbury Road**

C18. Three-bay timber-frame with a Queen post truss. Recent tile roof, half-hipped at ends and hipped above the projected central entrance. Boarded walling. An aisle of recent date has been added east of the entrance, with block walling.

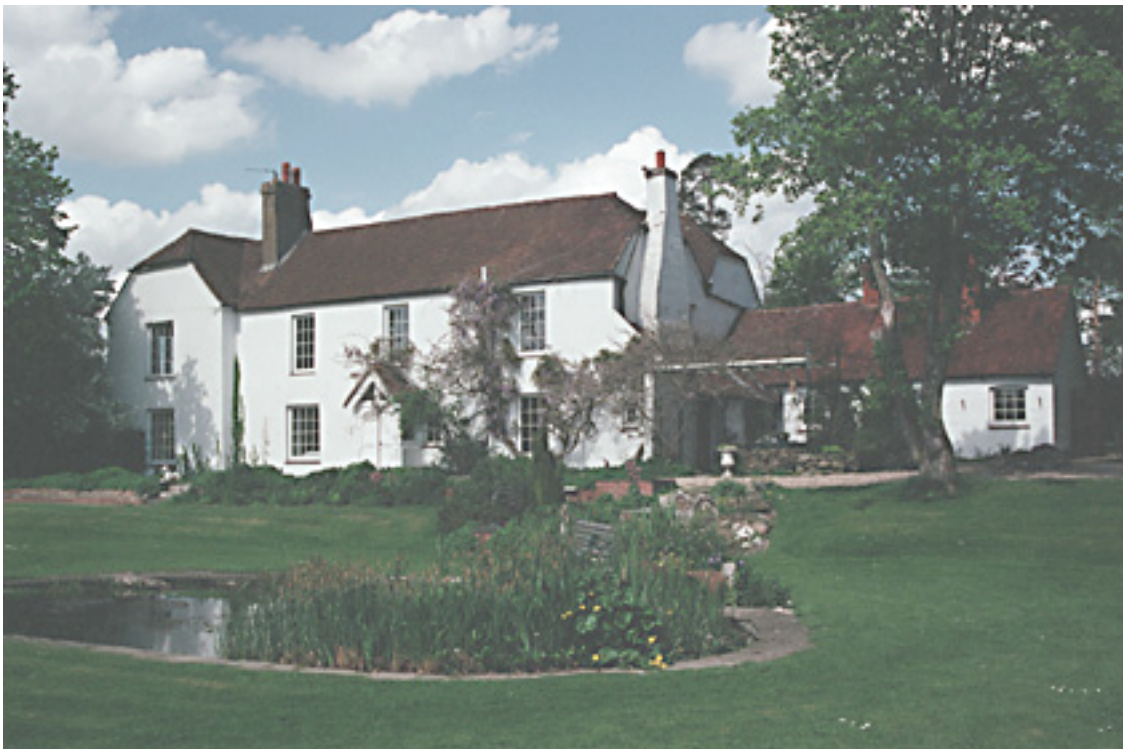
#### **Stantons Farmhouse, Newbury Road**

C17, C18, early C19. Double roofed main block of 2 storeys, with a 2-storeyed cross-wing at the south end, and a single-storeyed utility wing at the north. The front (east) has 1.3 windows. Tile roof, half-hipped gable to the slightly-projecting south side, half-hipped elsewhere. Rendered walling. Sashes in reveals. Victorian open gabled porch with timber-frame on side walls; old 6-panelled door. The south elevation is symmetrical, of 2 windows, the former central doorway now being a window. Inside, heavy beams and part-exposure of horizontal timbers (and massive chimney breasts) reveal an earlier origin, of
