## Kingsclere

- a village with 95 listed buildings

Chris Watkins

2020

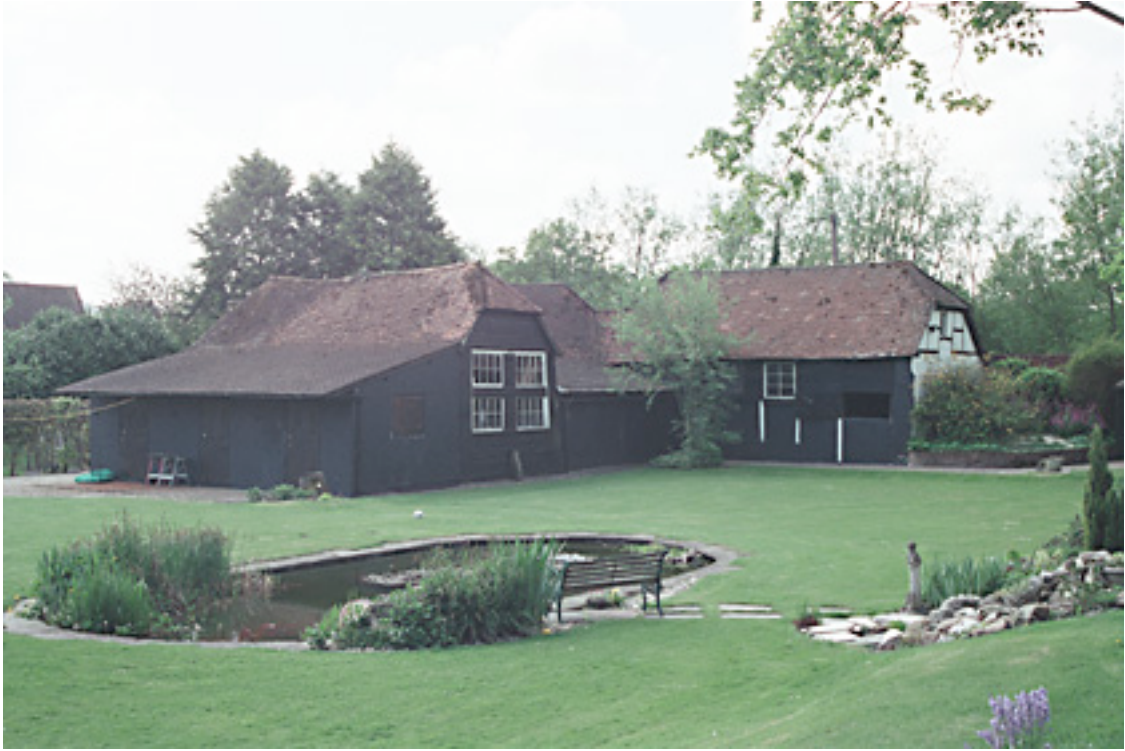
**barn at Stantons Farmhouse, Newbury Road**

C18, C19. Two timber-framed barns, each of 4 bays, meeting at right-angles, with an aisle on the inner side of the later unit. The older part has a form of Queen post with inward-curving struts, the other has straight struts. Tile roofing, half-hipped at the ends, with a wagon entrance at the northern bay. The older part has a gable with exposed framing, filled with painted brickwork; most walling being boarded. Modernised as stables.

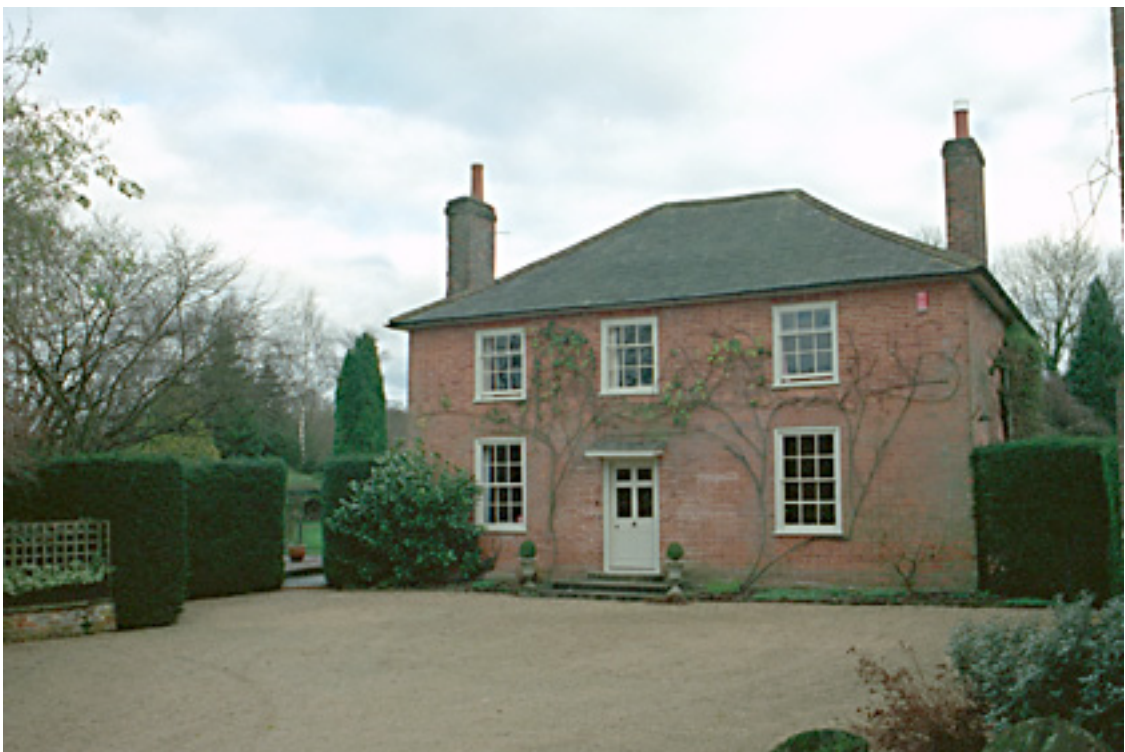
**Island Mill House, Union Lane (formerly listed as Lower Mill, house and granary)**

Early C19. Near-symmetrical front (west) of 2 storeys, 3 windows. Low-pitched hipped slate roof. Red brick walling in Flemish bond, rubbed flat arches, arched staircase window at the rear. Sashes in exposed frames. The doorway has a moulded canopy with a panelled soffit, above an architrave, enclosing a 6-

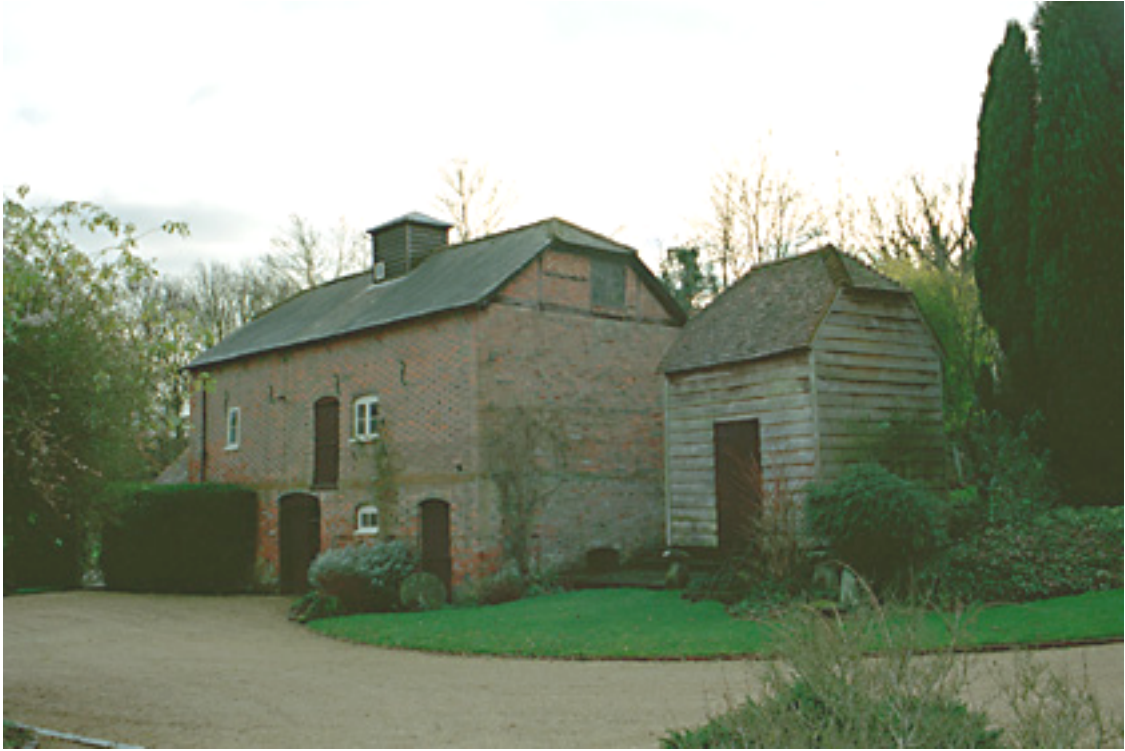
#### **Mill at Island Mill House, Union Lane**

Early C19. Plain rectangular block of 2 storeys and attic, irregular fenestration. Half-hipped slate roof. Walling of red brickwork in Flemish bond with blue headers, cambered openings: arched water entry. Within, the machinery and heavy timbers of the supports are complete.

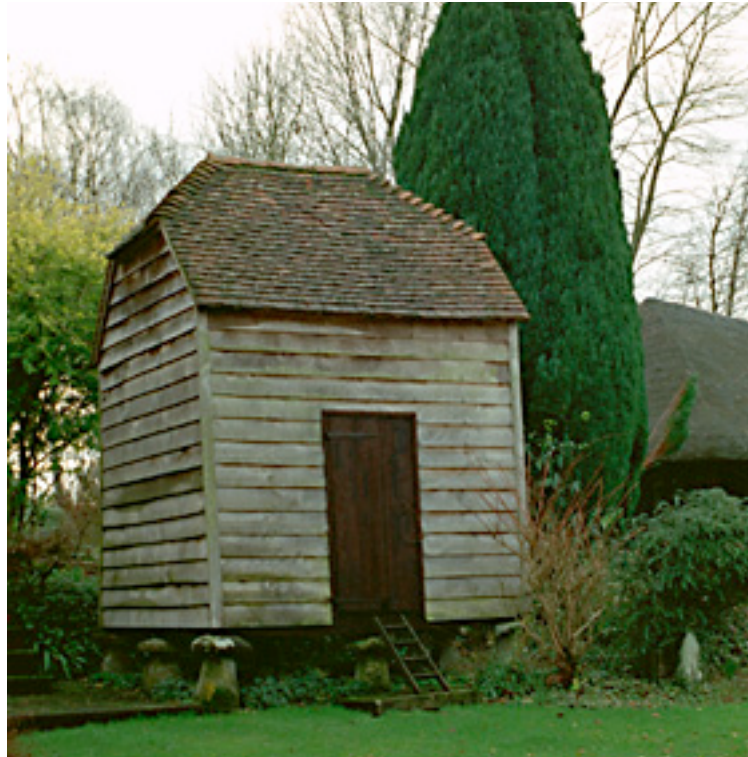
### **Granary at Island Millhouse, Union Lane**

Early C19. Small, tall timber-frame on 6 staddles. Corrugated iron roof. Boarded walling.

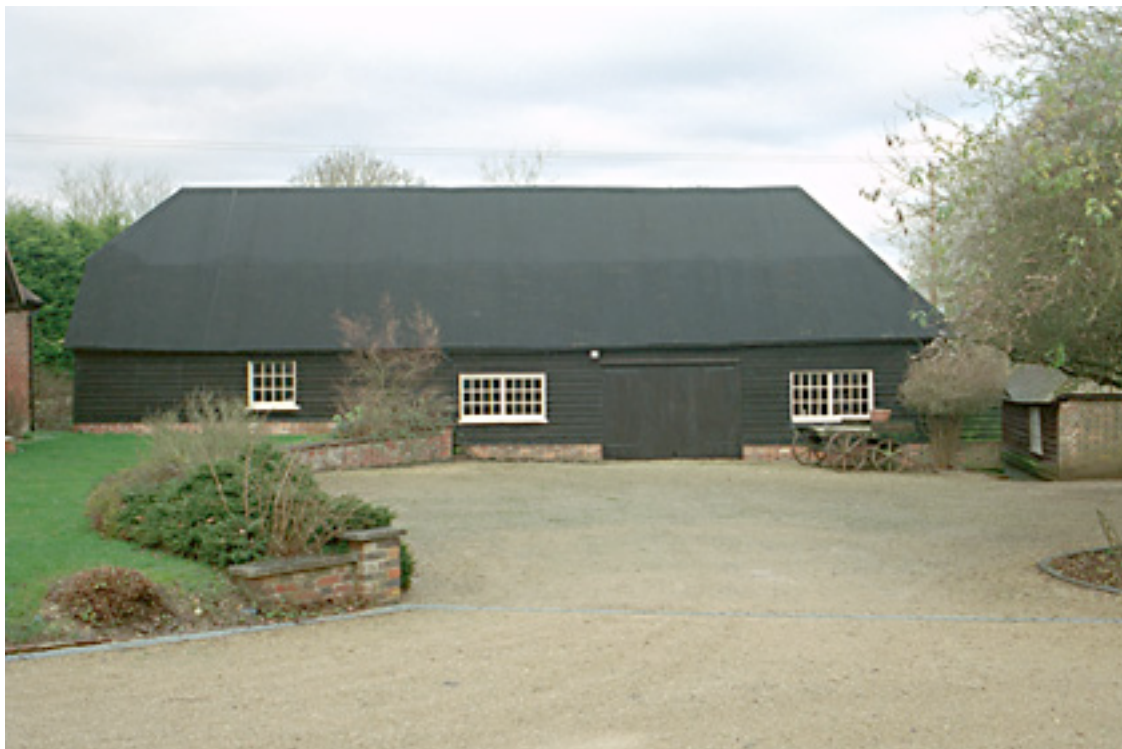
### **Barn at Island Millhouse, Union Lane**

Early C19. Timber-frame of 3 bays with central projecting entrance and aisle at the east end, later extension at the west end. Queen post truss. Corrugated iron roofing, hipped and half-hipped. Boarded walling above a brick base.

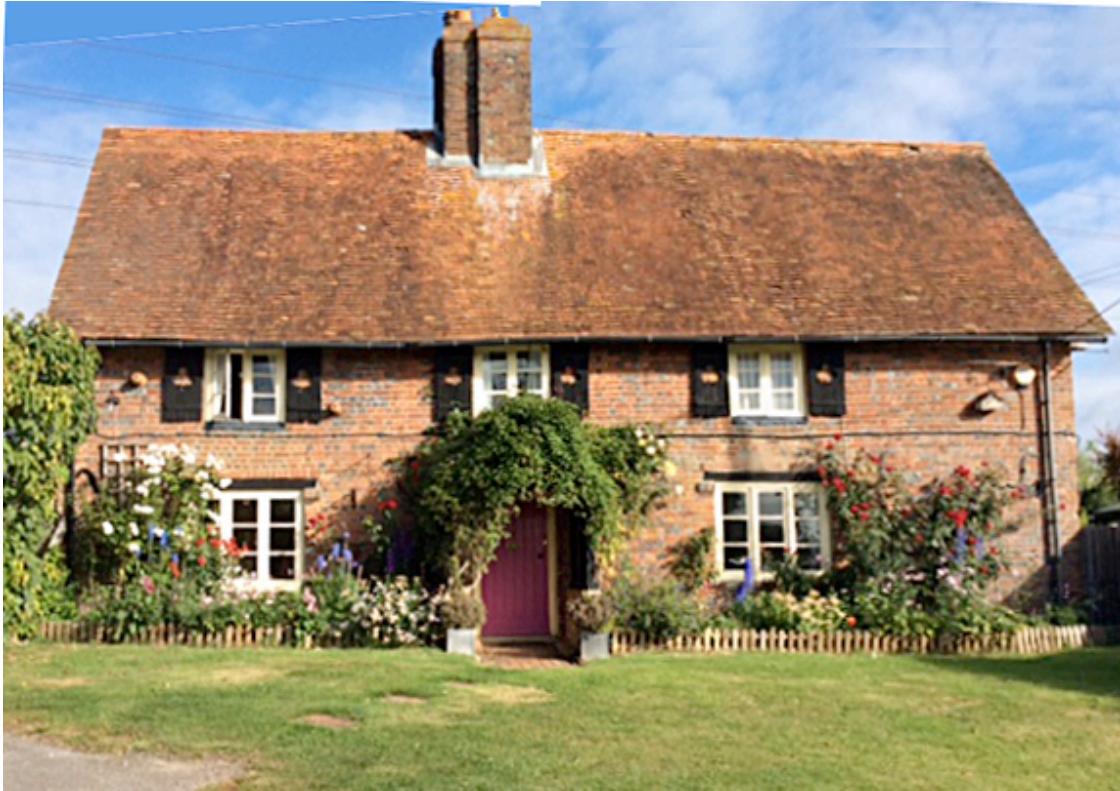
**Hall's Farmhouse, Union Lane**

C17, C18 and early C19. Timber-framed house, refronted at the last date. Tile roof, slate above rear outshots, large central shafted stack. The rear wall has exposed framing (bricknogged), the west gable is mainly tile-hung, the front is of red brickwork in a mixed bond. Casements. Tudor-arched plain doorway with a boarded door. The east end has timber-framing in the gable, above a C18 brick wall, with cambered openings.

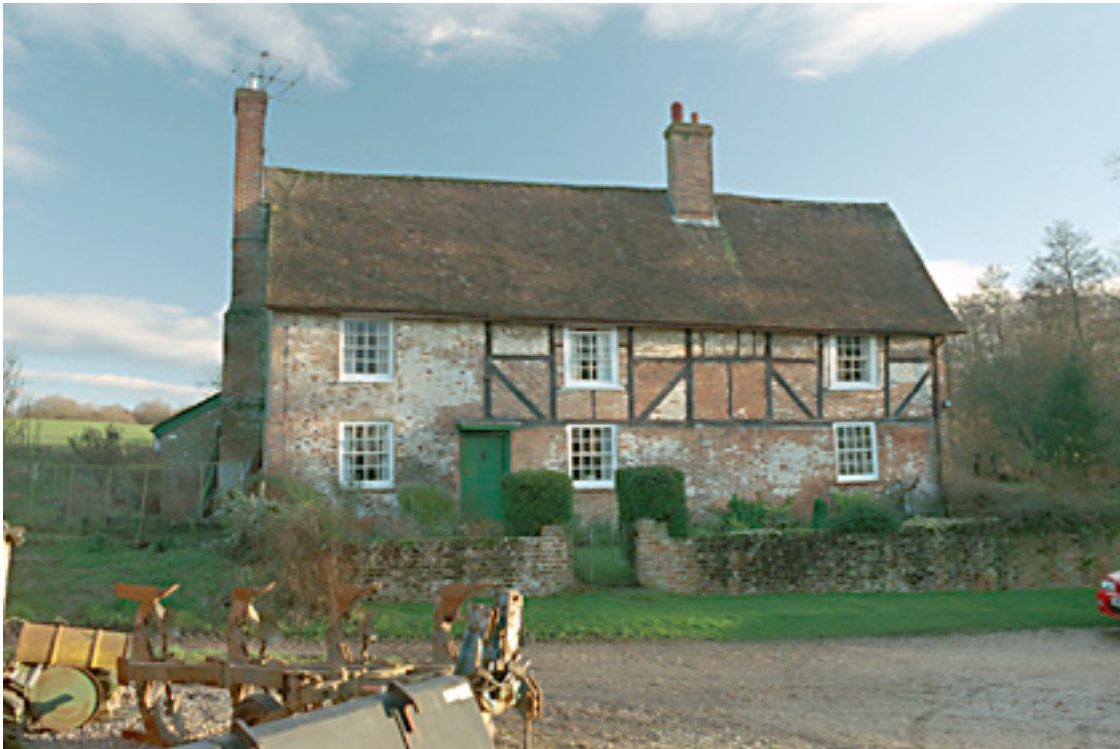
**Harriden Farmhouse, Union Lane**

C18, early and late C19. Timber-framed house with later alterations, extensions, and cladding: 2 storeys, 3 windows. Tile roof, massive tapered stack at one end, 2 within. Most of the front upper wall has exposed framing, bricknogged with some herring-bone panels, the ground-floor and north side having brickwork in Monk and Flemish bonds, one rubbed flat arch, plinth. Sashes in exposed frames (small mullions under the eaves, within a brick panel, indicate an early light). Doorway with moulded canopy

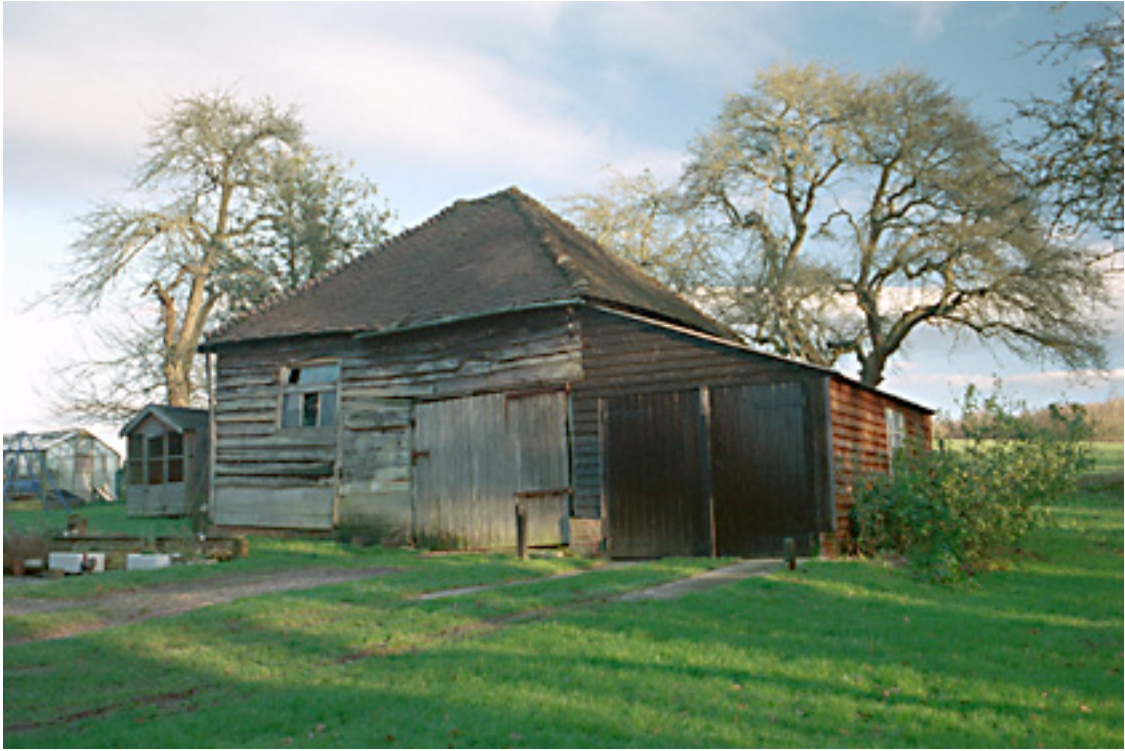
**Small barn or granary at Harriden Farmhouse, Union Lane**  
C18. Two-bay timber-frame, now on a brick base. Half-hipped tile roof. Boarded walls.

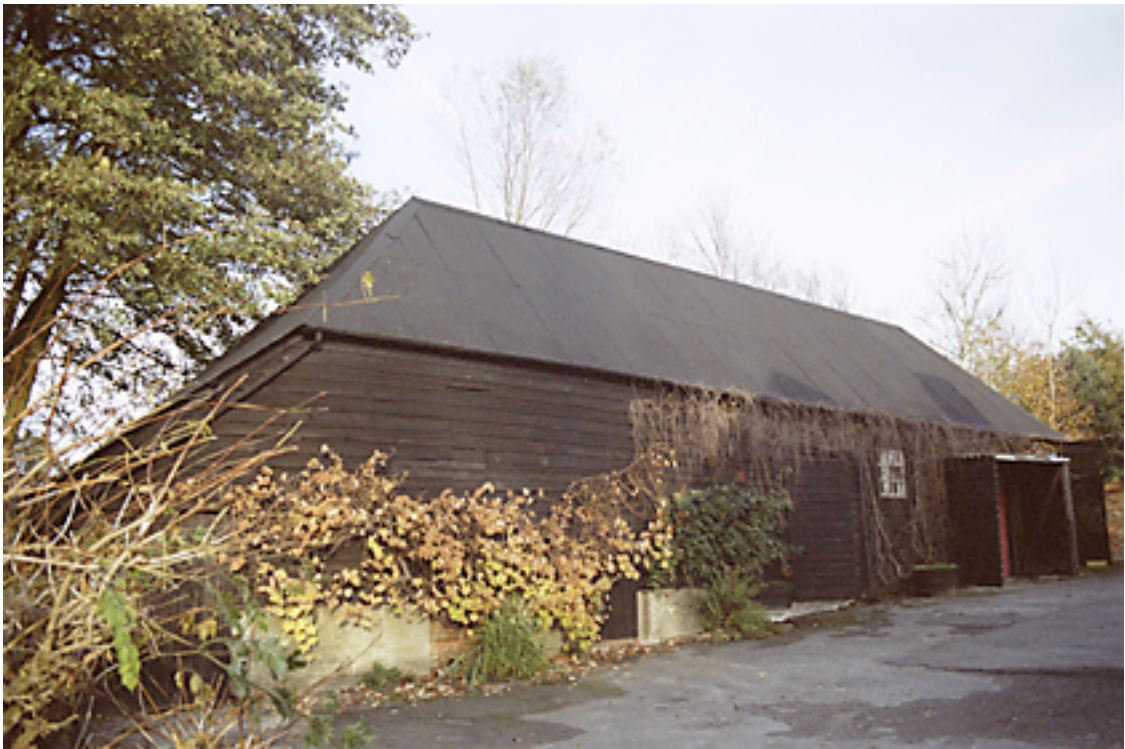
**Barn at Nutkins Farmhouse, Union Lane**  
C18. Four-bay timber-frame with aisles on one long and one short side. Queen post truss. Corrugated-iron roof. Boarded walls.

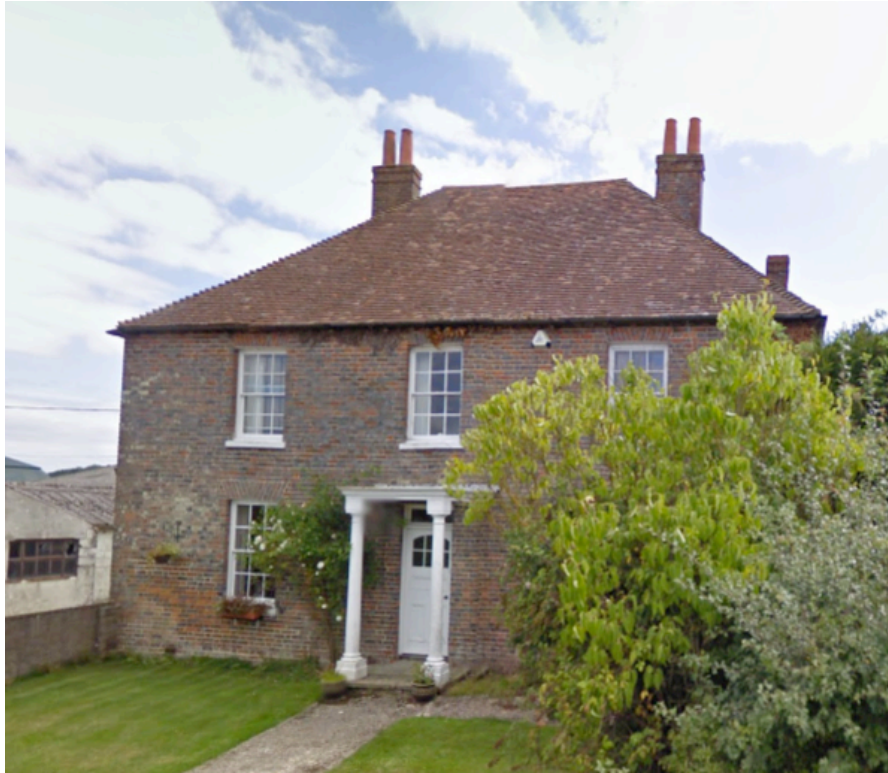
### **Upper House Farmhouse, Union Lane**

Early C19. Symmetrical front (west) of 2 storeys, 3 windows. Hipped tile roof, brick dentil eaves. Blue and brindle brick walling in Flemish bond, Dutch flat arches, stone cills. Sashes in reveals. Tuscan porch of simple form, with a fanlight above a recent half-glazed door.

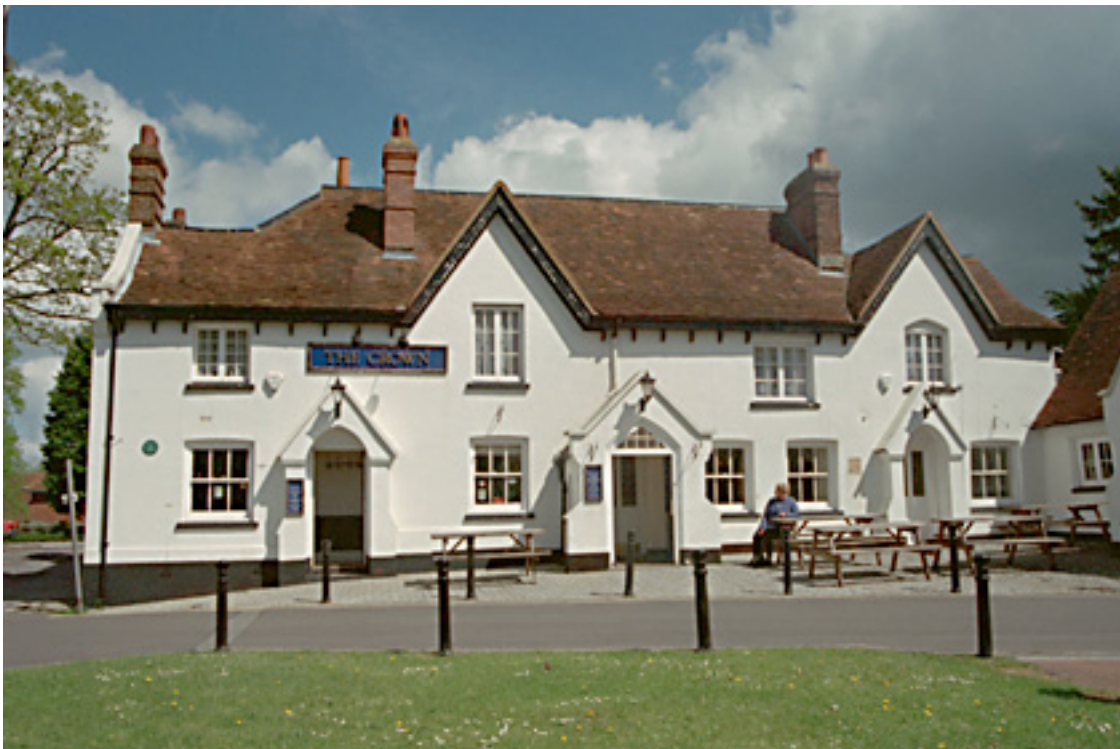
### **The Crown Public House, North Street**

C17, late C19. A Victorian-Tudor refronting of former 3 cottages, of timber-framed origin (surviving within on the first-floor). Two storeys. Tile roof; hipped projections at the rear, the front having 2 gables, with brackets to the intervening eaves. The rendered walling has a plinth. Casement upper windows, sashes to the ground-floor. Three Gothic entrances, the central one projecting as a porch, with gables, impost mouldings to Tudor arches, lower buttresses. To the east side a small hall projects forward of

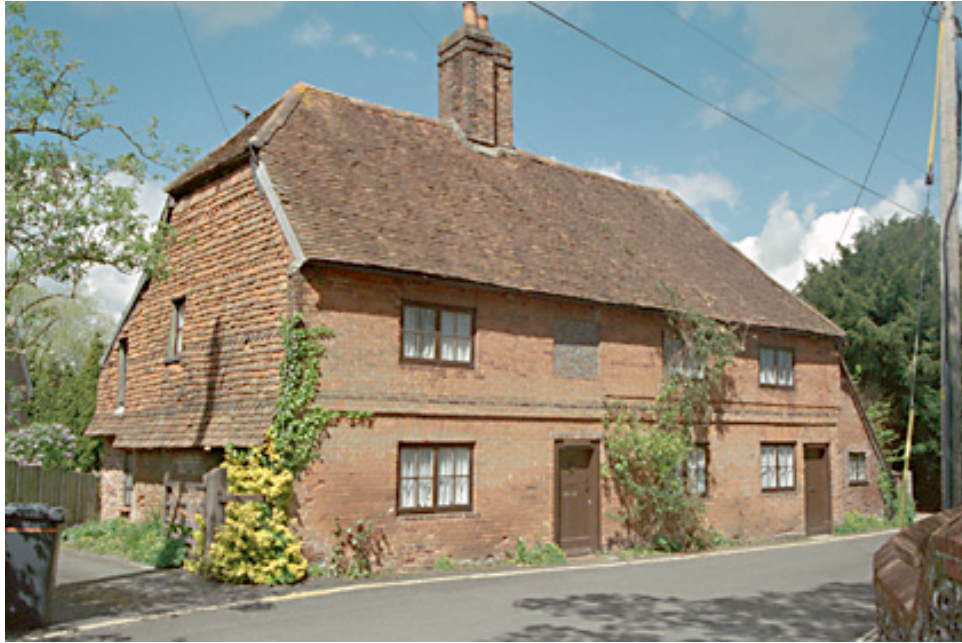
### 3 and 5 North Street

C15, C18, C20. A C18 re-fronting of a medieval timber-framed house. Tile roof, half-hipped at the south side and brought to a low eaves at the north-side outshot, catslide at the rear; shafted stack. Front wall in red brickwork, Flemish bond, rubbed flat arches, first floor band, blue header panel above the doorway to No 3, the south wall is mostly tile-hung, with scalloped bands. Wood casements. Two boarded doors in solid frames. Within, the timber-frame is fairly complete, the north side being a 2-bay unit at right-angles, containing an upper window of 2-lights with cusped heads. The stack has been inserted. The ground-floor of No 3 has C17 panelling, a complete C18 corner cupboard, another C18, utility cupboard, and the old staircase with C18 rails.

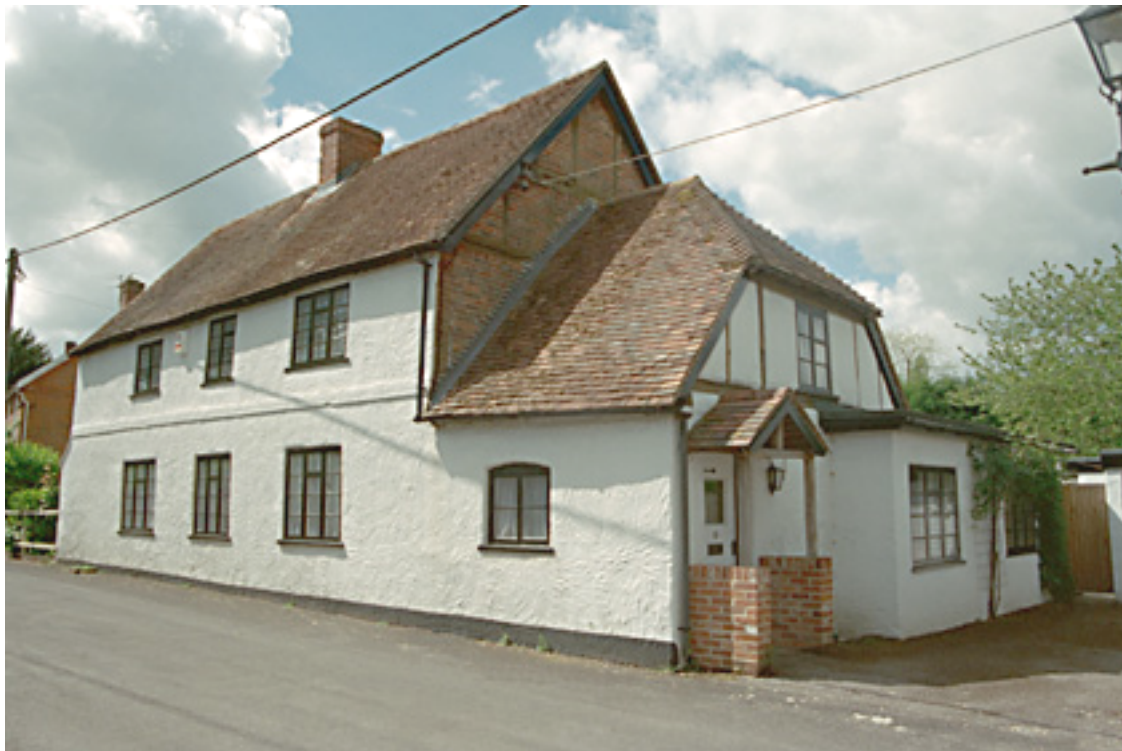
### 9, 11 and 13 North Street

C17, C18, C19. A timber-framed house with later cladding; 2.1 storeys, 3.1 windows. Tile roof, half-hipped to the single-storeyed north side, hipped to the rear extension. The front (east) has roughcast walling, first floor band; the south gable has exposed framing with rendered infill to the first floor, corrugated iron cladding in the gables, and a tiled roof above the extended ground-floor wall. The north elevation has exposed framing. Casements. The building is now one dwelling, much modernised with a

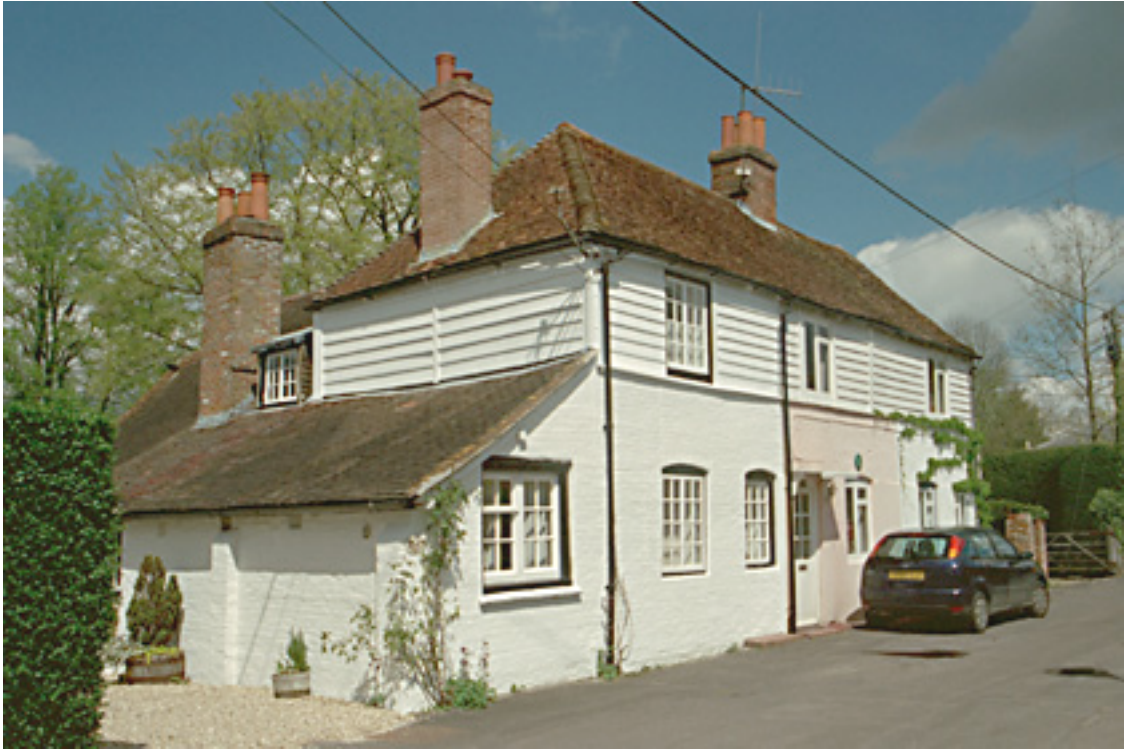
### **15, 19 and 21 North Street**

C18, C19. Short terrace of 2 storeys, 3 windows. Tile roof, hipped at the south side; slate roof to the south end outshot. Upper walling is boarded, the lower of painted brickwork in English Garden Wall bond (with some rendering), cambered ground-floor openings. Modern casements. Modern doors

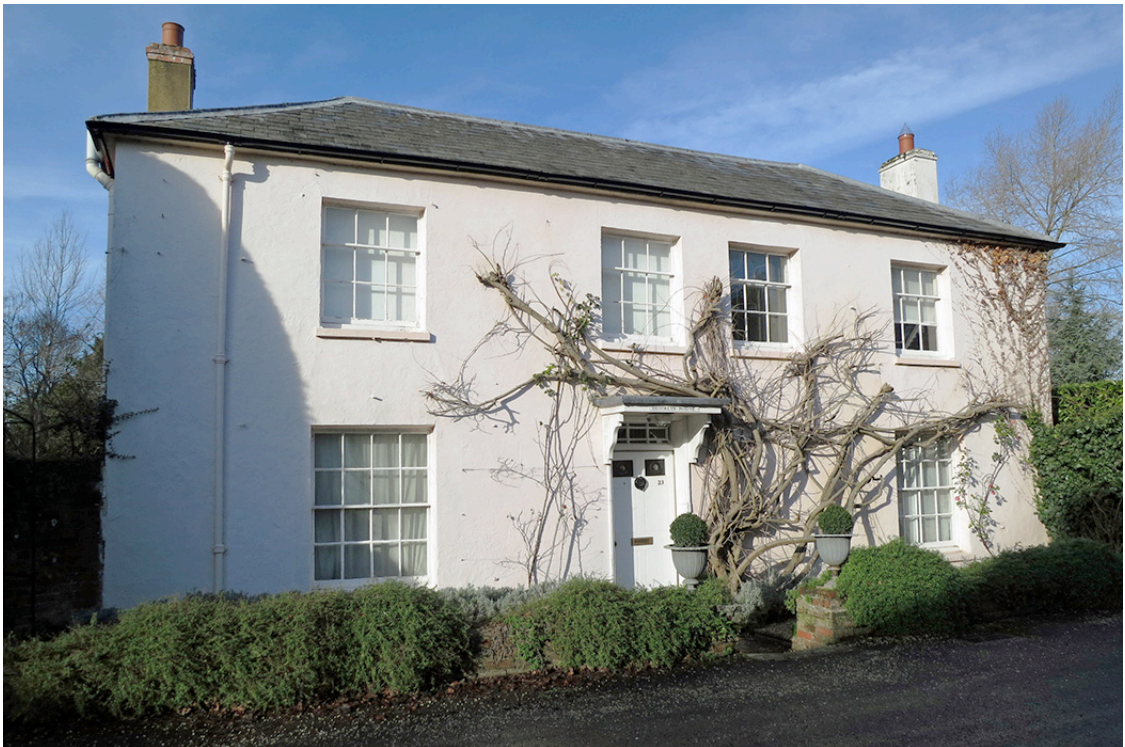
### **Brooklyn House, 23? North Street**

Early C19. Front of 2 storeys, 4 windows. Low-pitched hipped slate roof. Rendered walls, stone cills. Sashes in reveals. The doorway has a moulded canopy on carved brackets, a decorative fanlight, and a 6-flush-panelled (2 top glazed) door. To the south side there is a red brick boundary wall in Flemish bond, with flat buttresses and plinth.

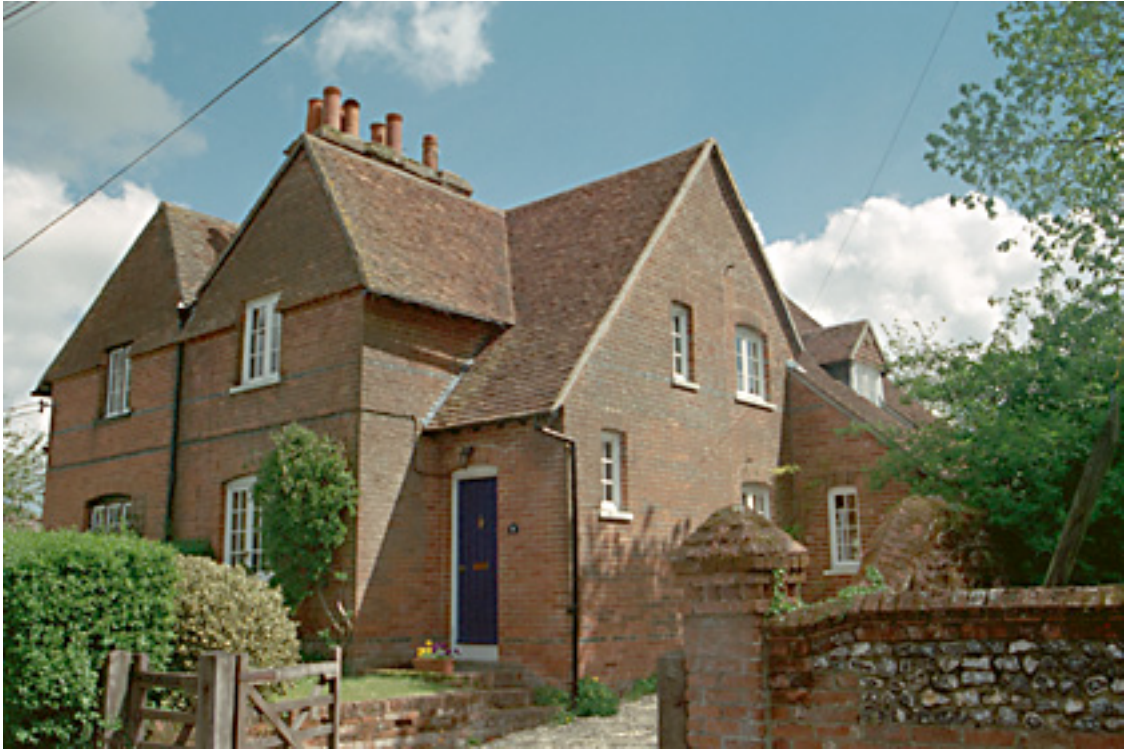
#### **6 and 8 North Street**

Circa 1900. A pair of cottages made unusual by the slight batter of tile-hung gables to front and rear. Two storeys, 2 windows. Tile roof, 2 middle gables, and brought to a low eaves above the doorways (in the set-back sides). Red brick walling in stretcher bond with blue flush bands at the levels of the upper cills, first-floor, and ground-floor. Casements. Plain doors.

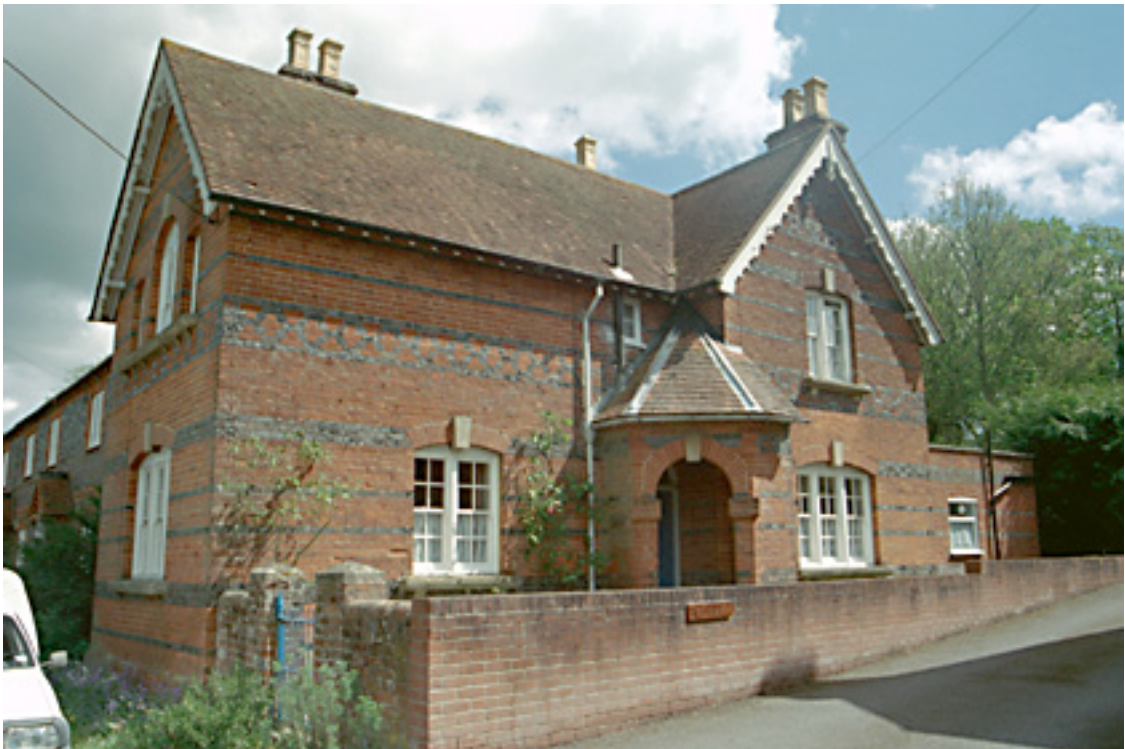
#### **24 North Street "Schoolmasters House"**

Mid C19. Decorative Gothic style. Two storeys, 3 above one window to the gabled front (west). Steep tiled roof, with decorative bargeboards. Red brick walling in Flemish bond with flush blue banding in a variety of widths and patterns, cambered red openings with keys, taller arch with key to the central upper lights, plinth. Sashes, with rounded heads below a circular light in the upper central window. Recessed at the south side is a quarter-octagonal porch, with a hipped roof, and arched opening, on brick impost

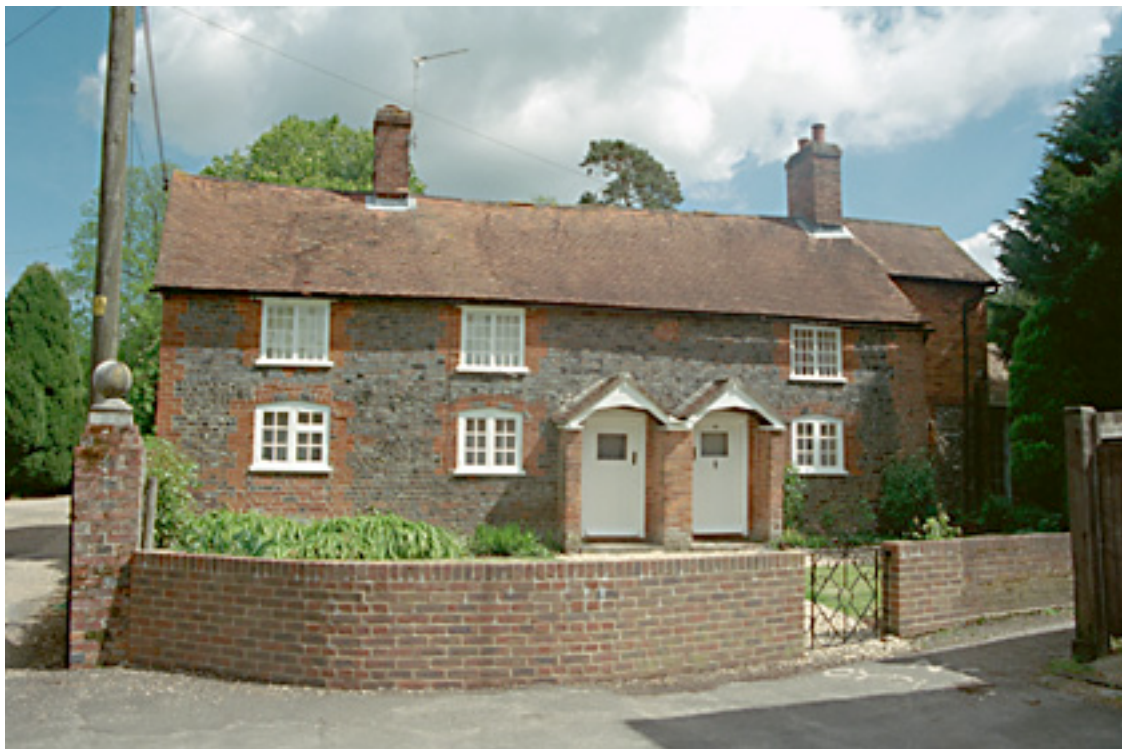
**26 and 28 North Street**

Mid C19. A wide symmetrical pair with a front of 2 storeys, 6 windows. Hipped tile roof, carved brick dentil eaves; central stack of blue brickwork, with panels. Walling of blue brickwork in Flemish bond, with red dressings; eaves fascia, first-floor band (with blue header decoration), plinth; stone hood-moulds to the ground-floor. Shallow porches have pointed arches on brick pilasters, and boarded doors in solid frames.

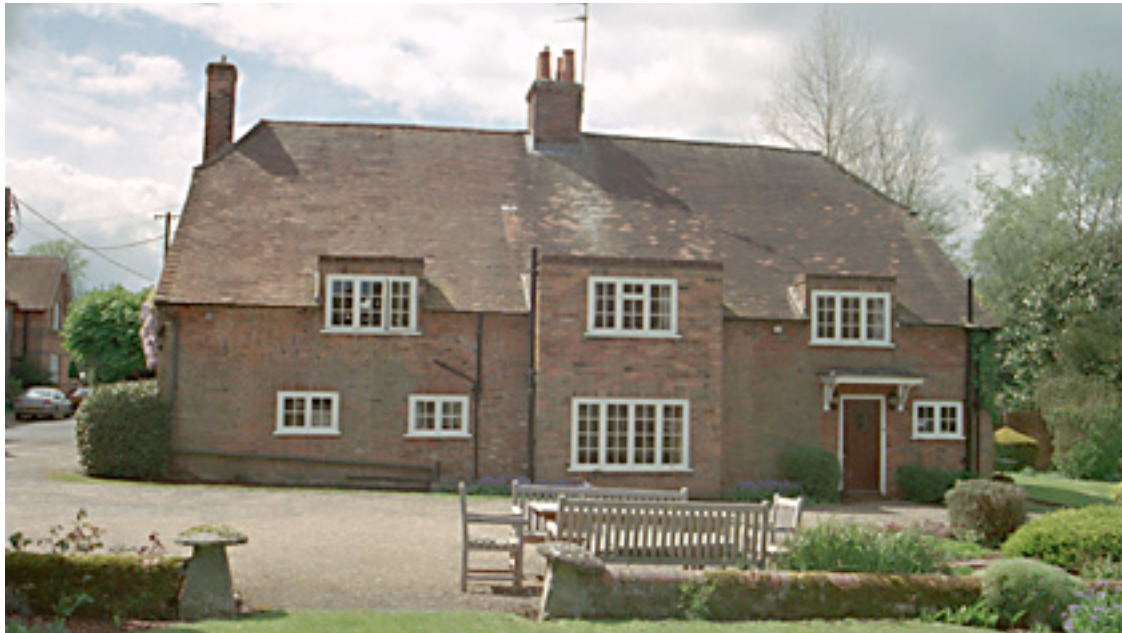
**30 and 32 North Street**

1863. Probably designed as a symmetrical terrace of 4; the easternmost unit is now set back, leaving a non-symmetrical pair. Two storeys. Tile roof. Walling of blue brickwork in Flemish bond with flush red quoins to openings and the west side, the east ending in red brick walling with a plinth: the ground-floor openings have angular arches. Open shallow porches have angular barge-boards, resting on impost blocks above red brick piers: plain doors. A small terra-cotta tile is inscribed Victoria Place 63; its position above the coupled porches and the replacement by a window of a former west-side doorway suggests the

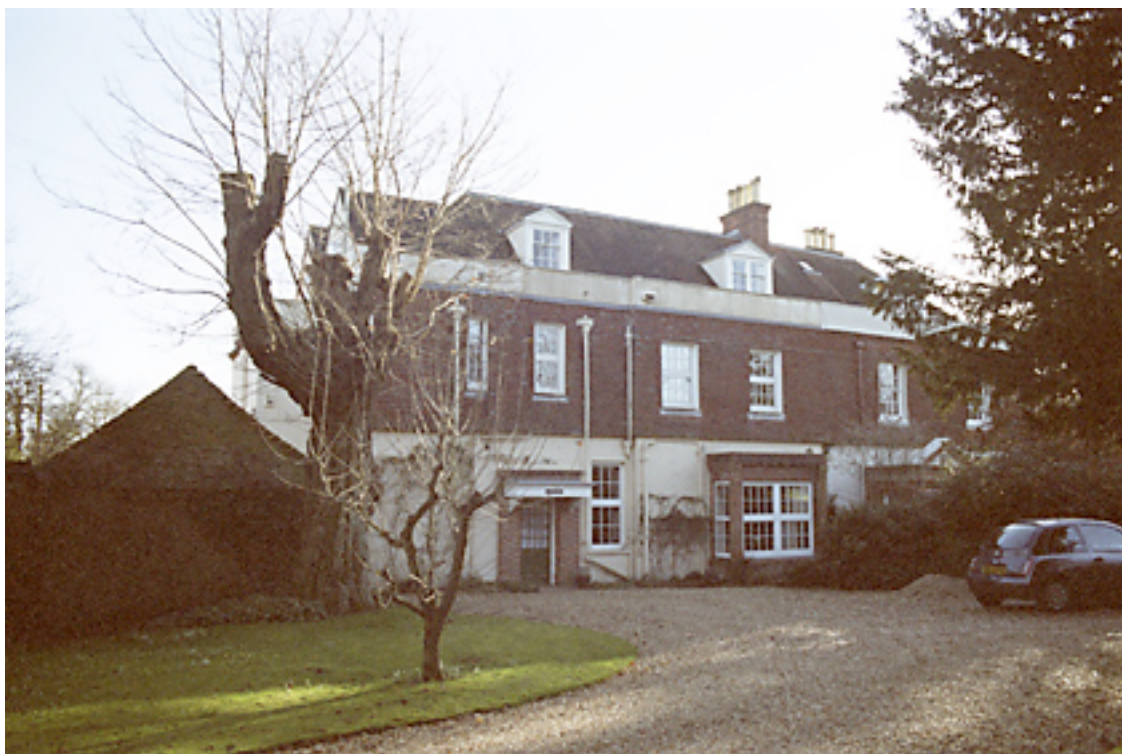
### **Priors Mill, North Street**

C18, early C19. Symmetrical front (south) of the earlier period, with equal extensions at each side of the later; 2 storeys, 1.3.1 windows. Half-hipped tile roof. Red brick walling in Flemish bond with blue headers, stone cills: the central upper window is now filled with blue-header brickwork and the former central door is also filled. Sashes in reveals. Entrance at the east side.

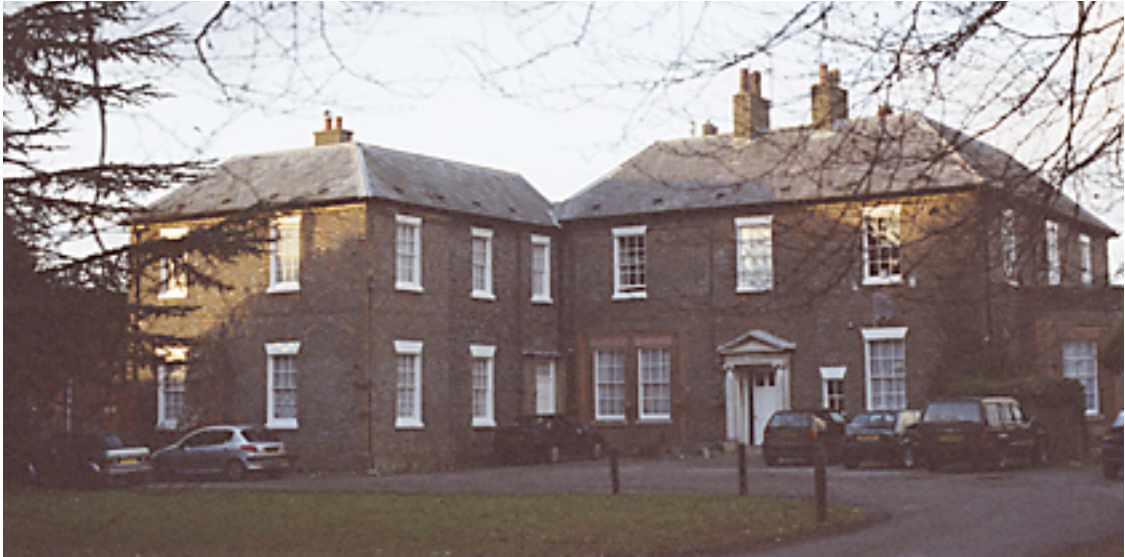
### **Kingsclere House, and Lake House, Fox's Lane**

Early C19, late C19. A large house, now 2 dwellings, having an older part with extensions on 2 sides of the later period. Two storeys and attic, fenestration now irregular. Hipped tile roofing, dormers with pediments and sash windows. Rendered walling, parapet (raised to a pediment in the centre of the symmetrical south elevation), brick band, much of the first-floor being tile-hung. Sashes in reveals, 2 rectangular brick bays with cornice and pilasters, one angular bay. The main entrance is a brick porch with a pediment (containing a shield), cornice and pilasters; at the north side is a later entrance with a brickwork panel enclosing a canopy on brackets.

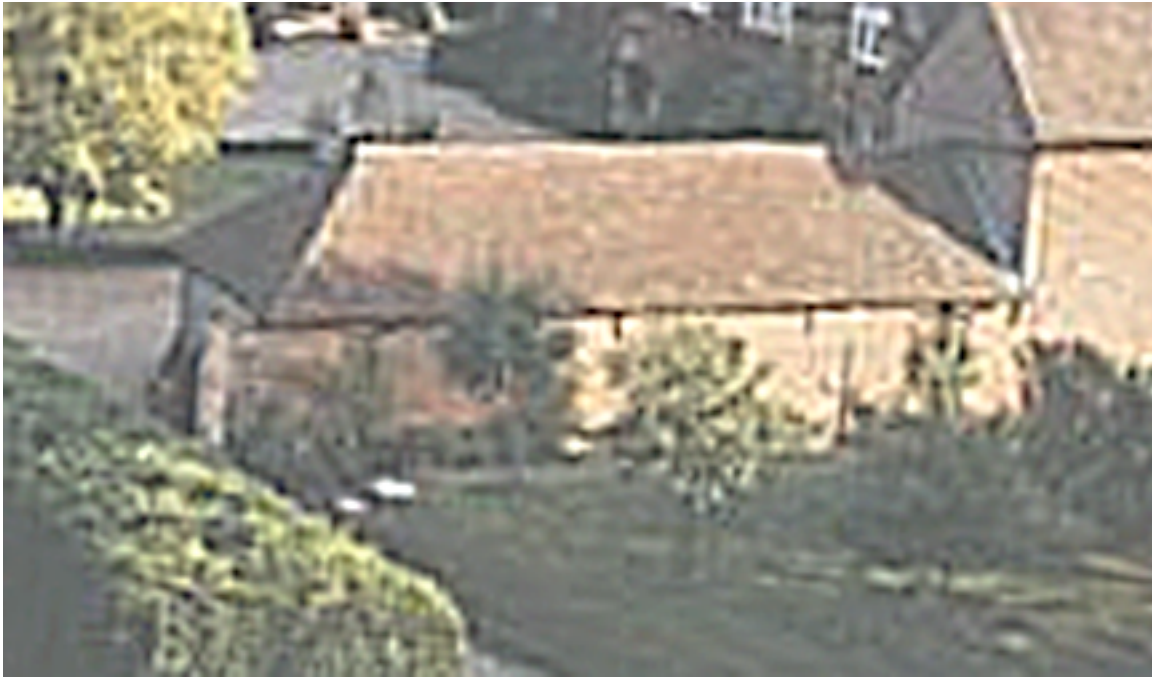
### **Barn at Knowl Farmhouse, Knowl Hill**

C17, early C19, C20. Once of 5 bays with central projection entrances, one-and-a-half units at the north end are part of a new building of similar external form (which is a replacement following a fire), all forming an L-shaped block. Ripped tile roofing; low eaves. The older part has massive timber-framing,
